Marinus Link EIS/EES Aboriginal and Historical Cultural Heritage Technical Study – Victorian Terrestrial Component

Marinus Link Pty Ltd

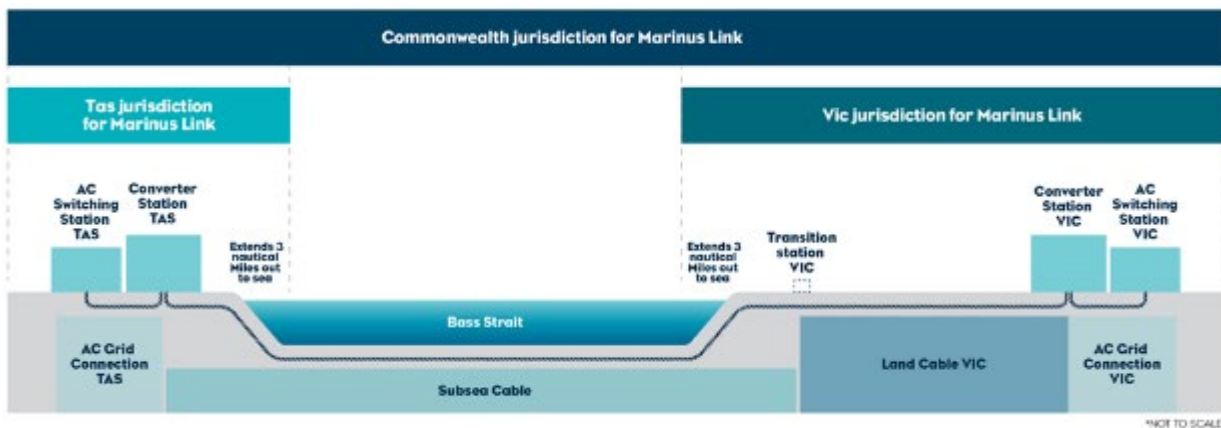
Figure 2: Project components considered under applicable jurisdictions (Marinus Link Pty Ltd 2022)

The assessment is focused on the Victorian section of the project. This report will inform the EIS/EES being prepared to assess the project's potential environmental effects in accordance with the legislative requirements of the Commonwealth and Victorian governments (see Figure 2).

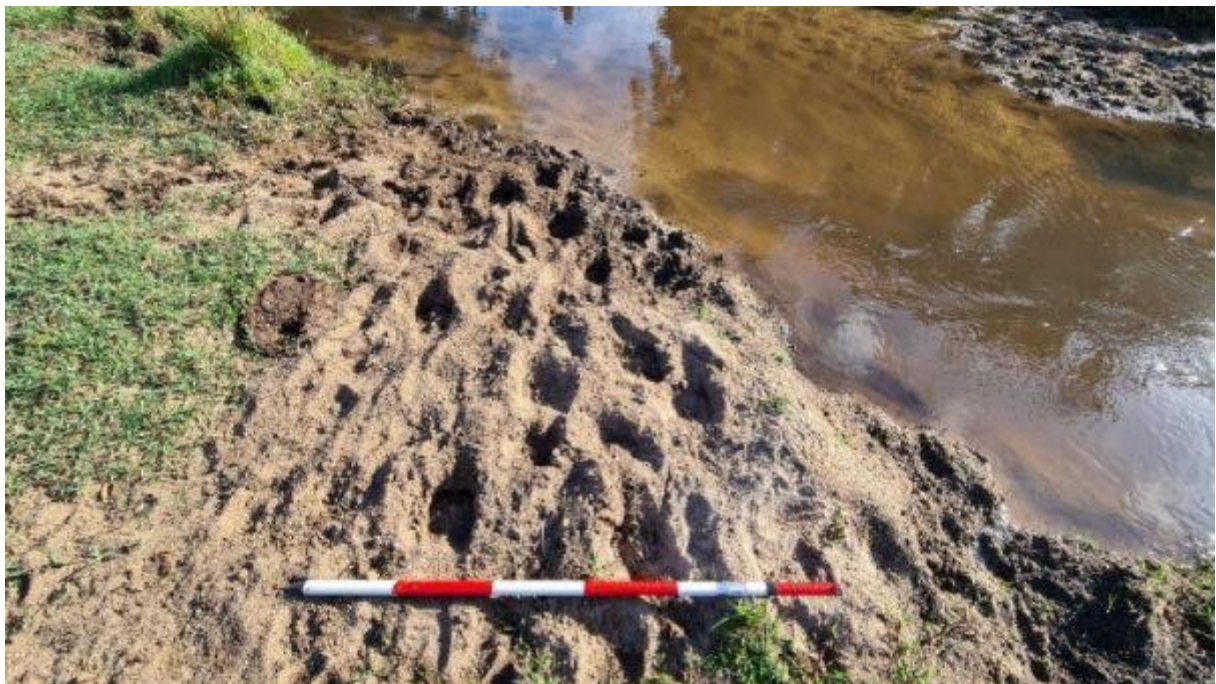
Plate 15: IA-3f, sandy exposure on the bank of the Little Morwell River

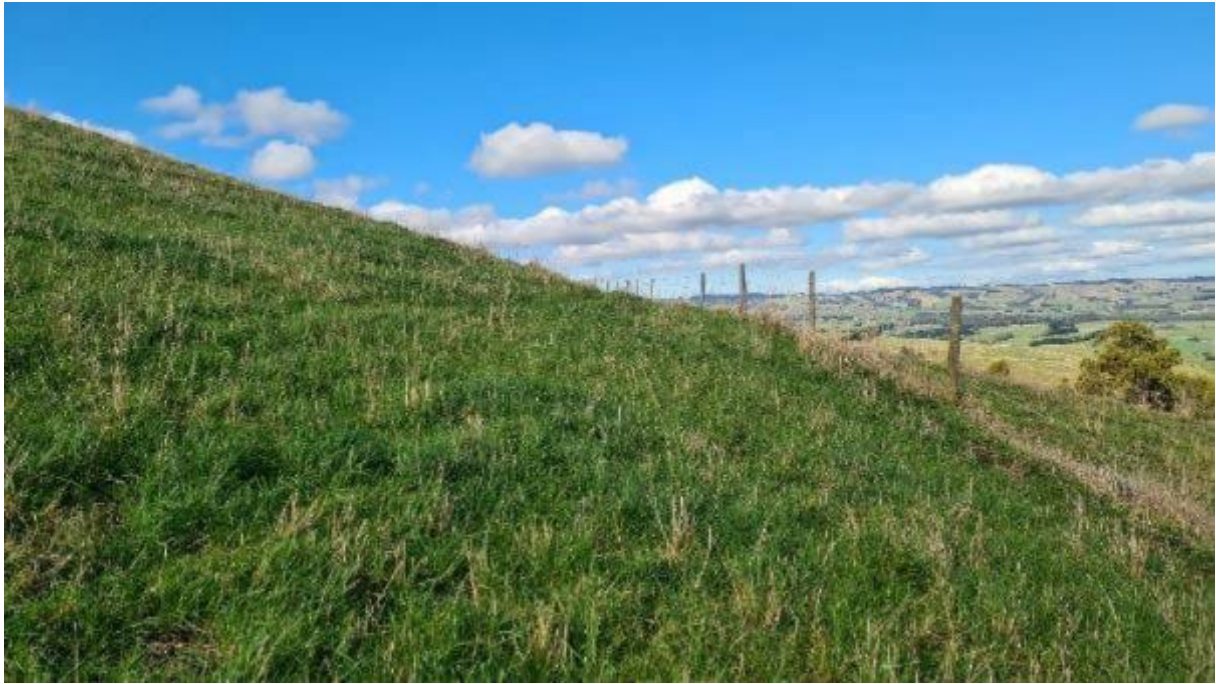
Plate 38: IA-7b, view east along a modified slope (terraced by cattle)

No Aboriginal or historical cultural heritage was identified in IA-7b. IA-7b was rated as having a moderate Aboriginal archaeological potential and a low historical archaeological potential.

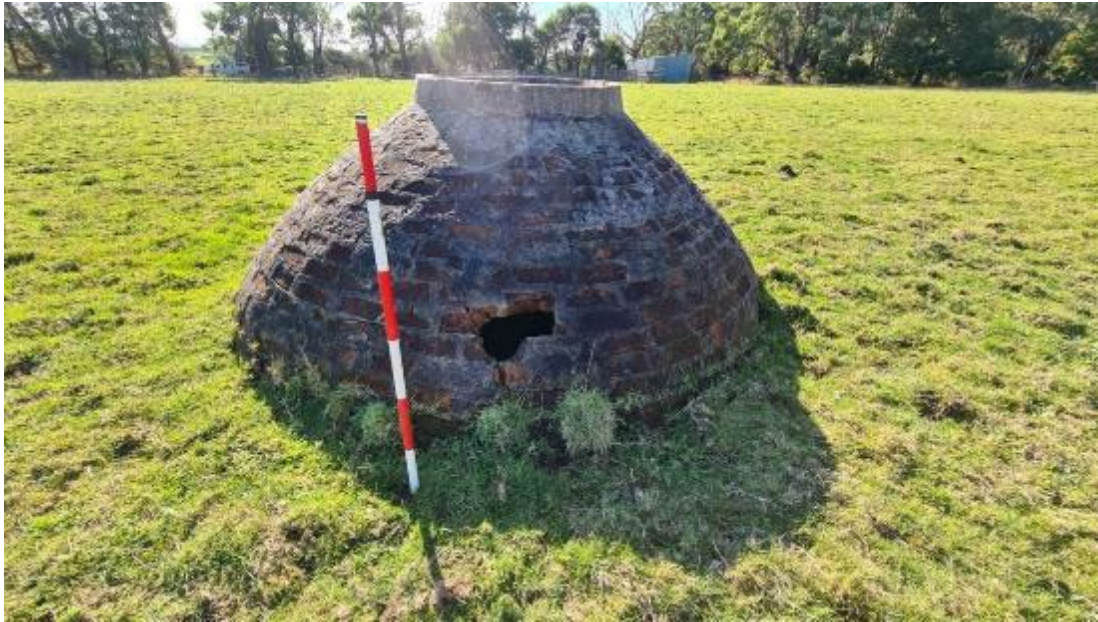
Plate 44: Brick cistern identified on Moores Road, Buffalo, view north-east

One historical archaeological site was identified during the archaeological ground survey, comprising a brick cistern located in IA-5 on a plain landform adjacent to Buffalo Creek (Plate 44 and Plate 45). A site card recommending listing of this place on the VHI has been drafted and will be submitted to HV.

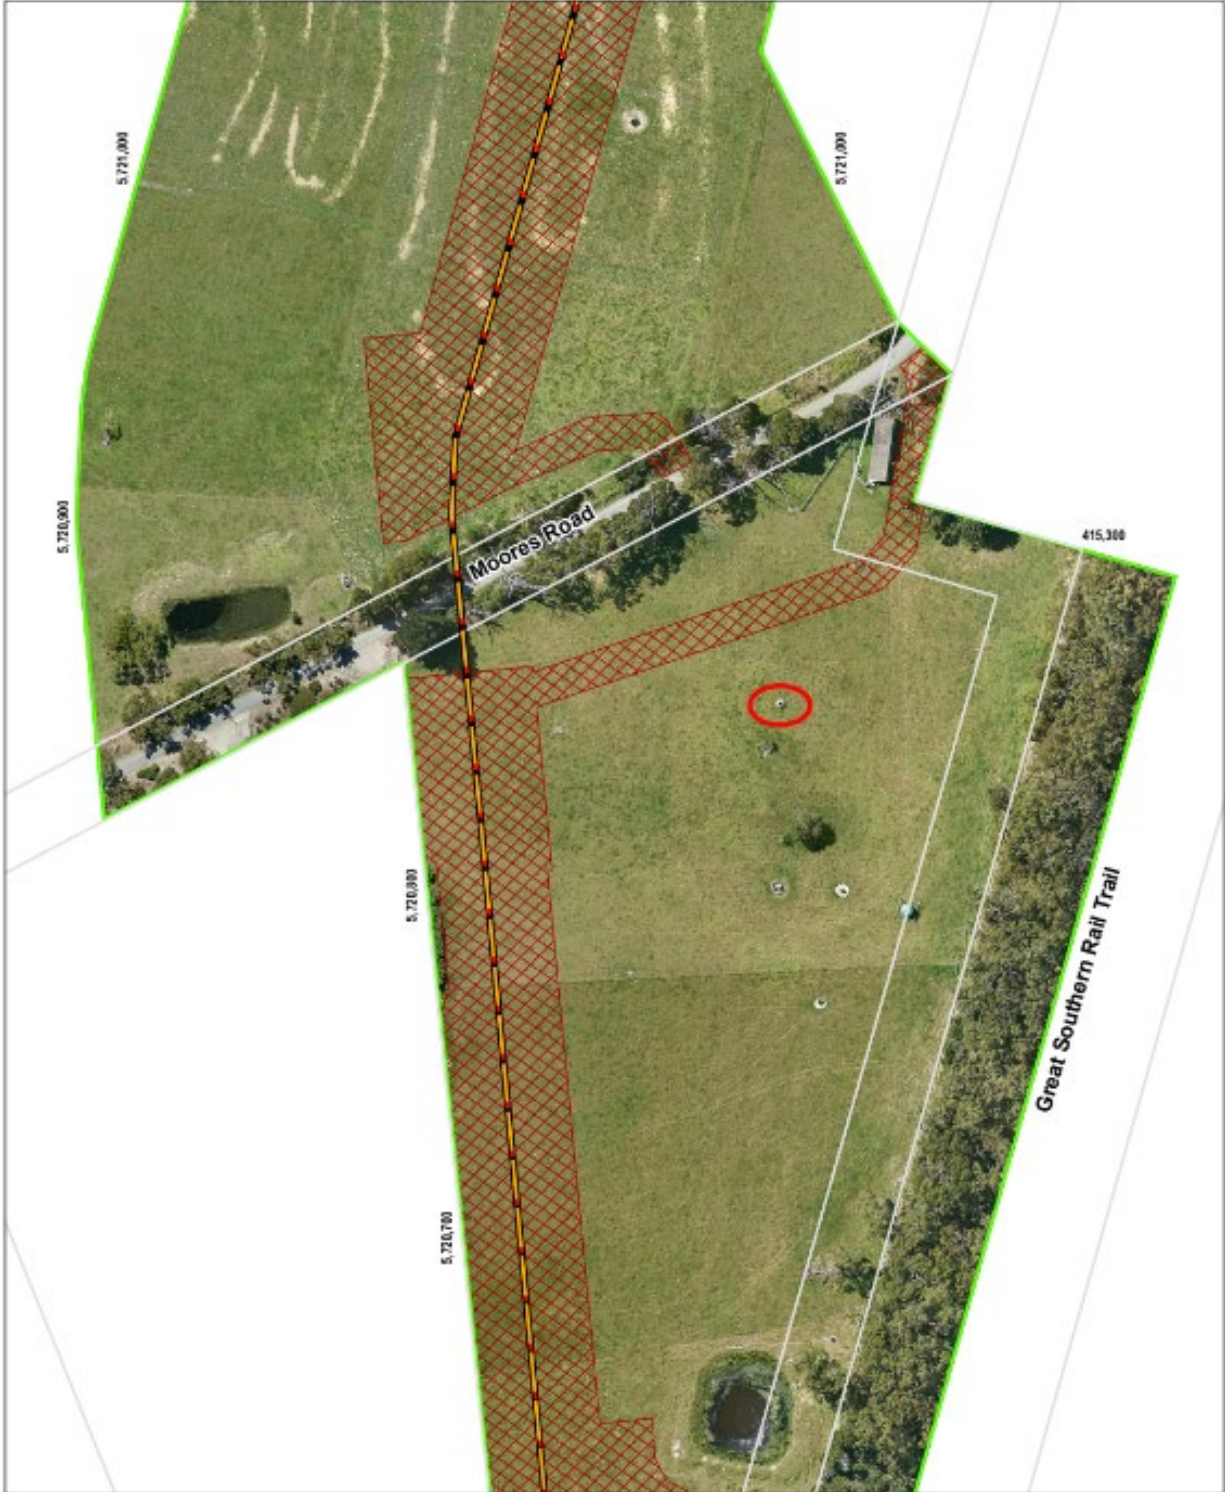
Figure 22: Aerial photograph of the Moores Rd property, Buffalo, showing the location of the brick cistern (circled in red)

property constructed in association with the cistern, and that the house had been dismantled and relocated, possibly near Waratah Bay (Darryl Jones, Marinus Link land access agent, pers comm. 1 March 2023). Despite the relocation of the original residence, there is a possibility that additional features or structures may remain within the property that are commonly associated with a cistern (e.g., a cesspit).

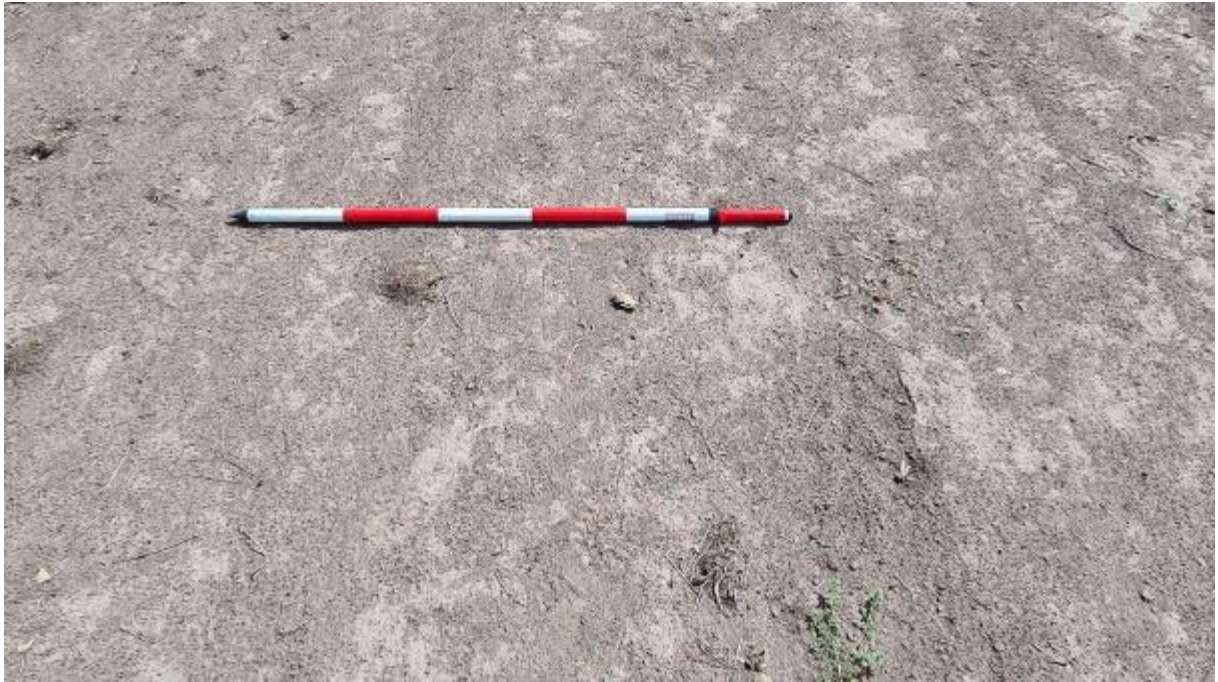
Plate 47: Flaked stone artefact within MRT 1, IA-4d

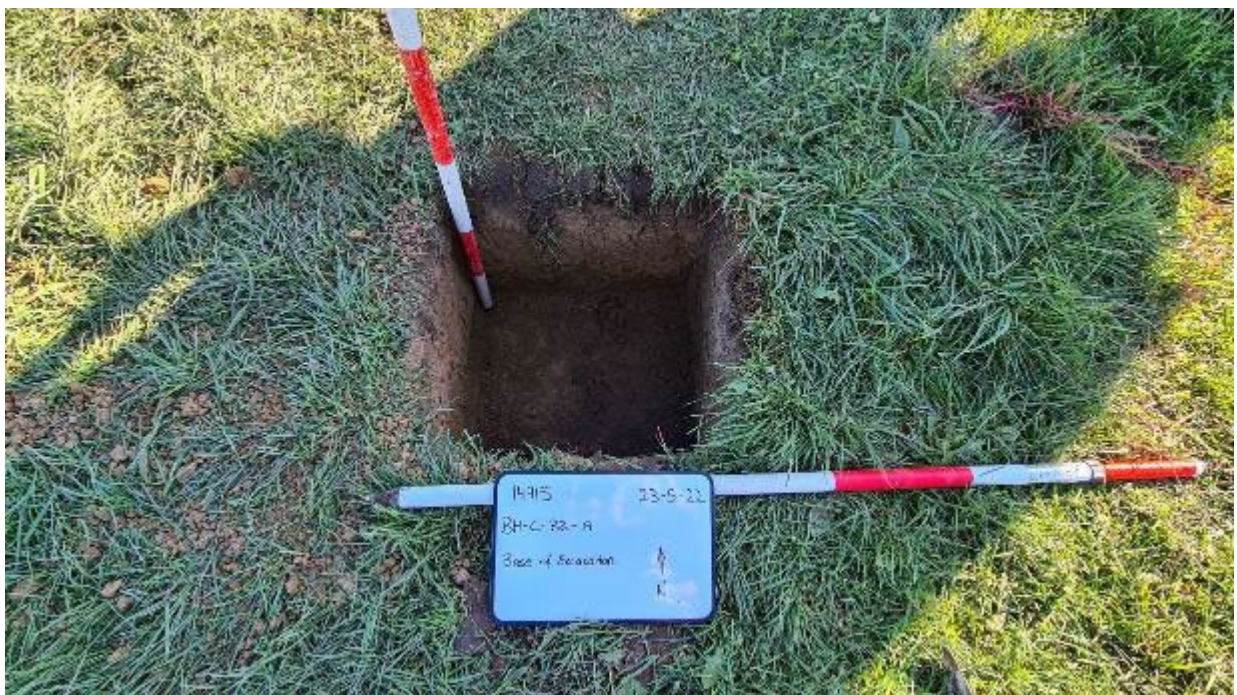
Plate 48: Example of an STP excavated during the subsurface testing program (STP BH-C-033-A, northern elevation)

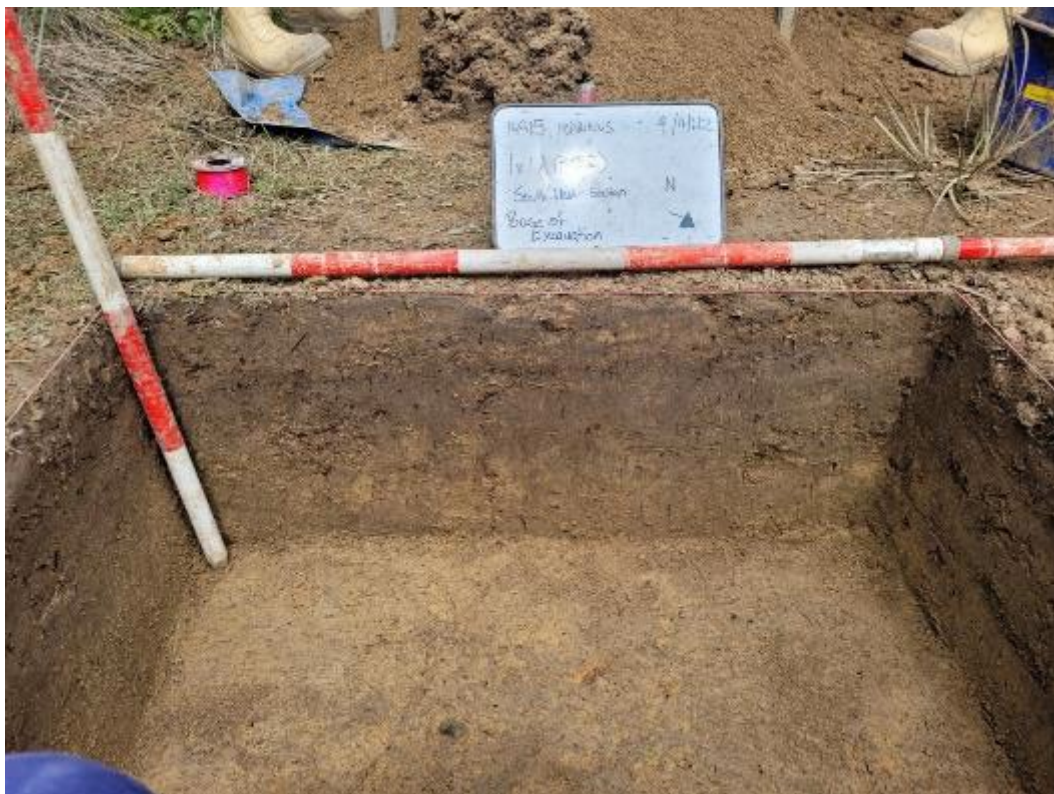
Plate 49: Example of a 1x1 m test pit excavated during the subsurface testing program (1x1A (IA-6b) west elevation)
