Marinus Link – Victorian Surface Water Impact
Assessment

May 2024

This report has been prepared by Alluvium Consulting Australia Pty Ltd for **Tetra Tech Coffey** under the contract titled '**Marinus Link Crossing Assessment**'.

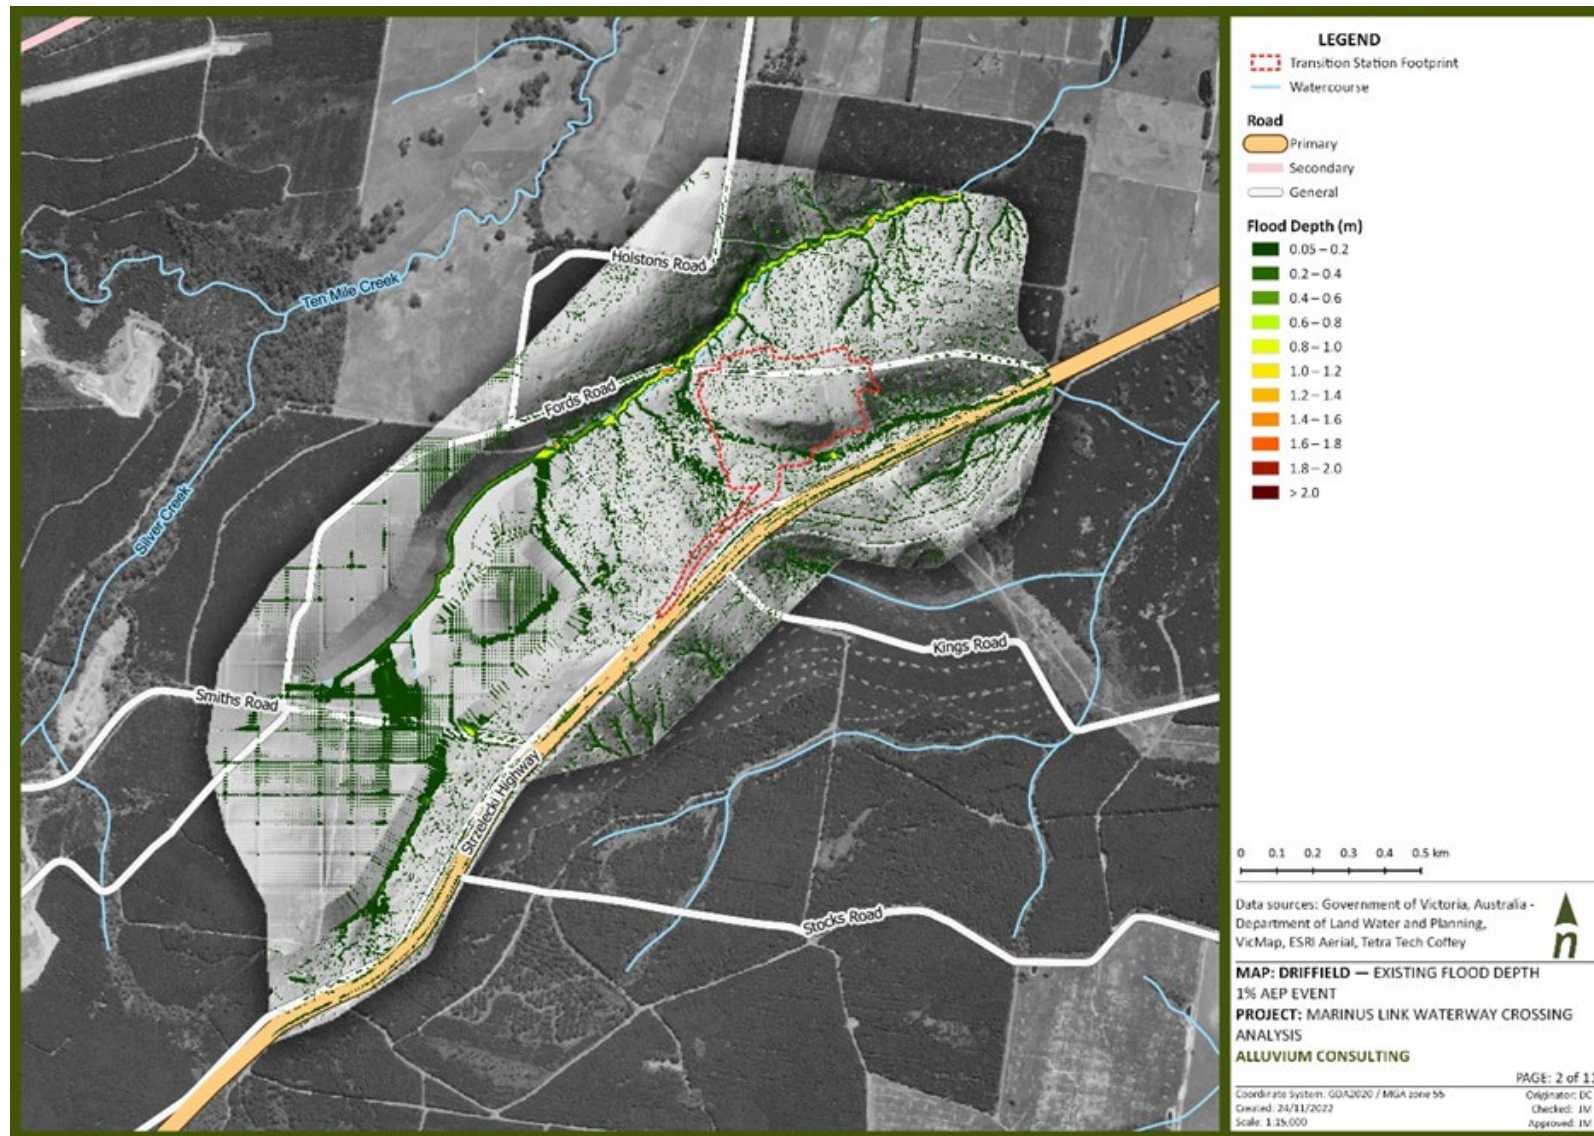
Figure 19. Driffield baseline characterisation 1% AEP flood depth

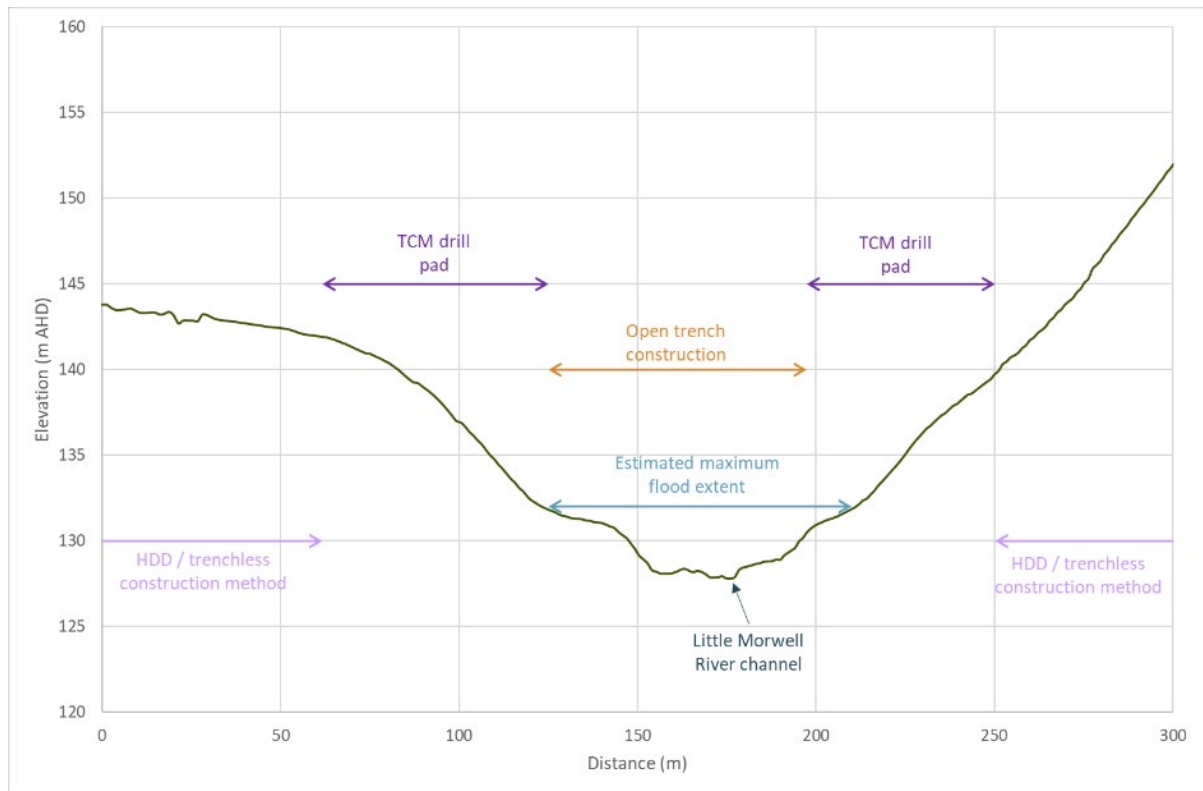
Figure 32. Schematic cross section layout of construction assets surrounding Little Morwell River crossing, looking downstream along proposed project alignment

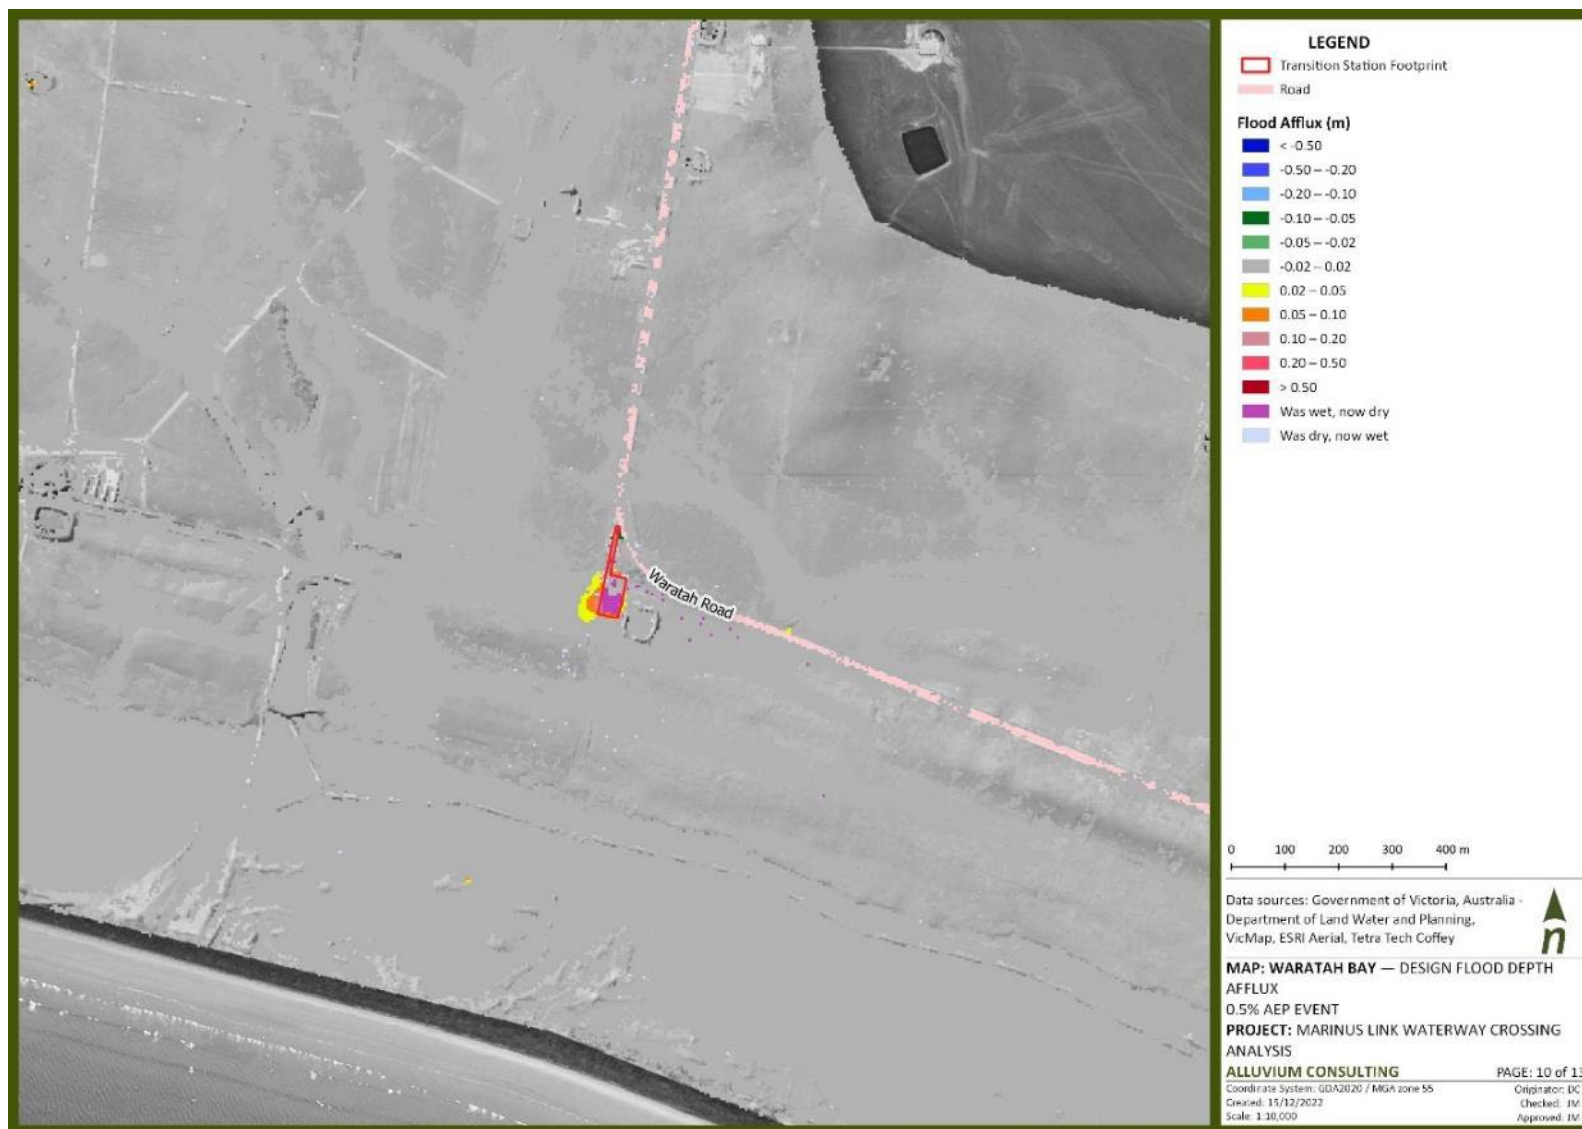
Figure 43. Waratah Bay 0.5 % AEP afflux

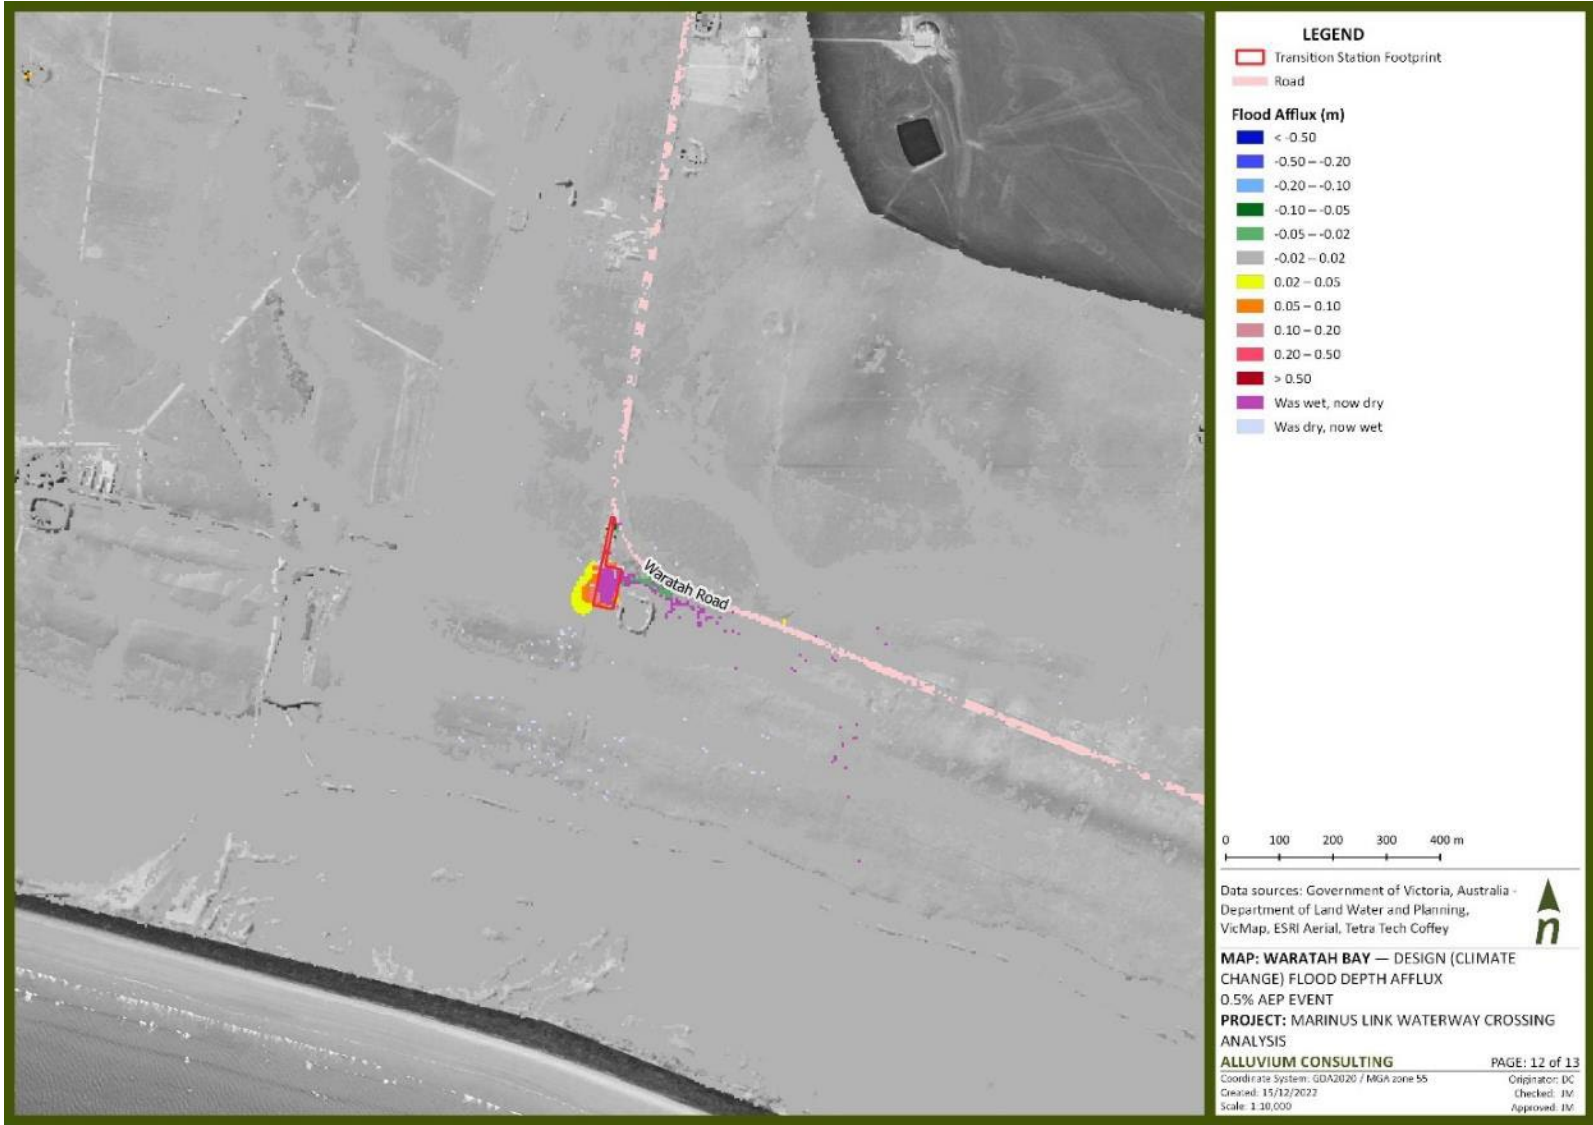
Figure 44. Waratah Bay climate change 0.5 % AEP afflux

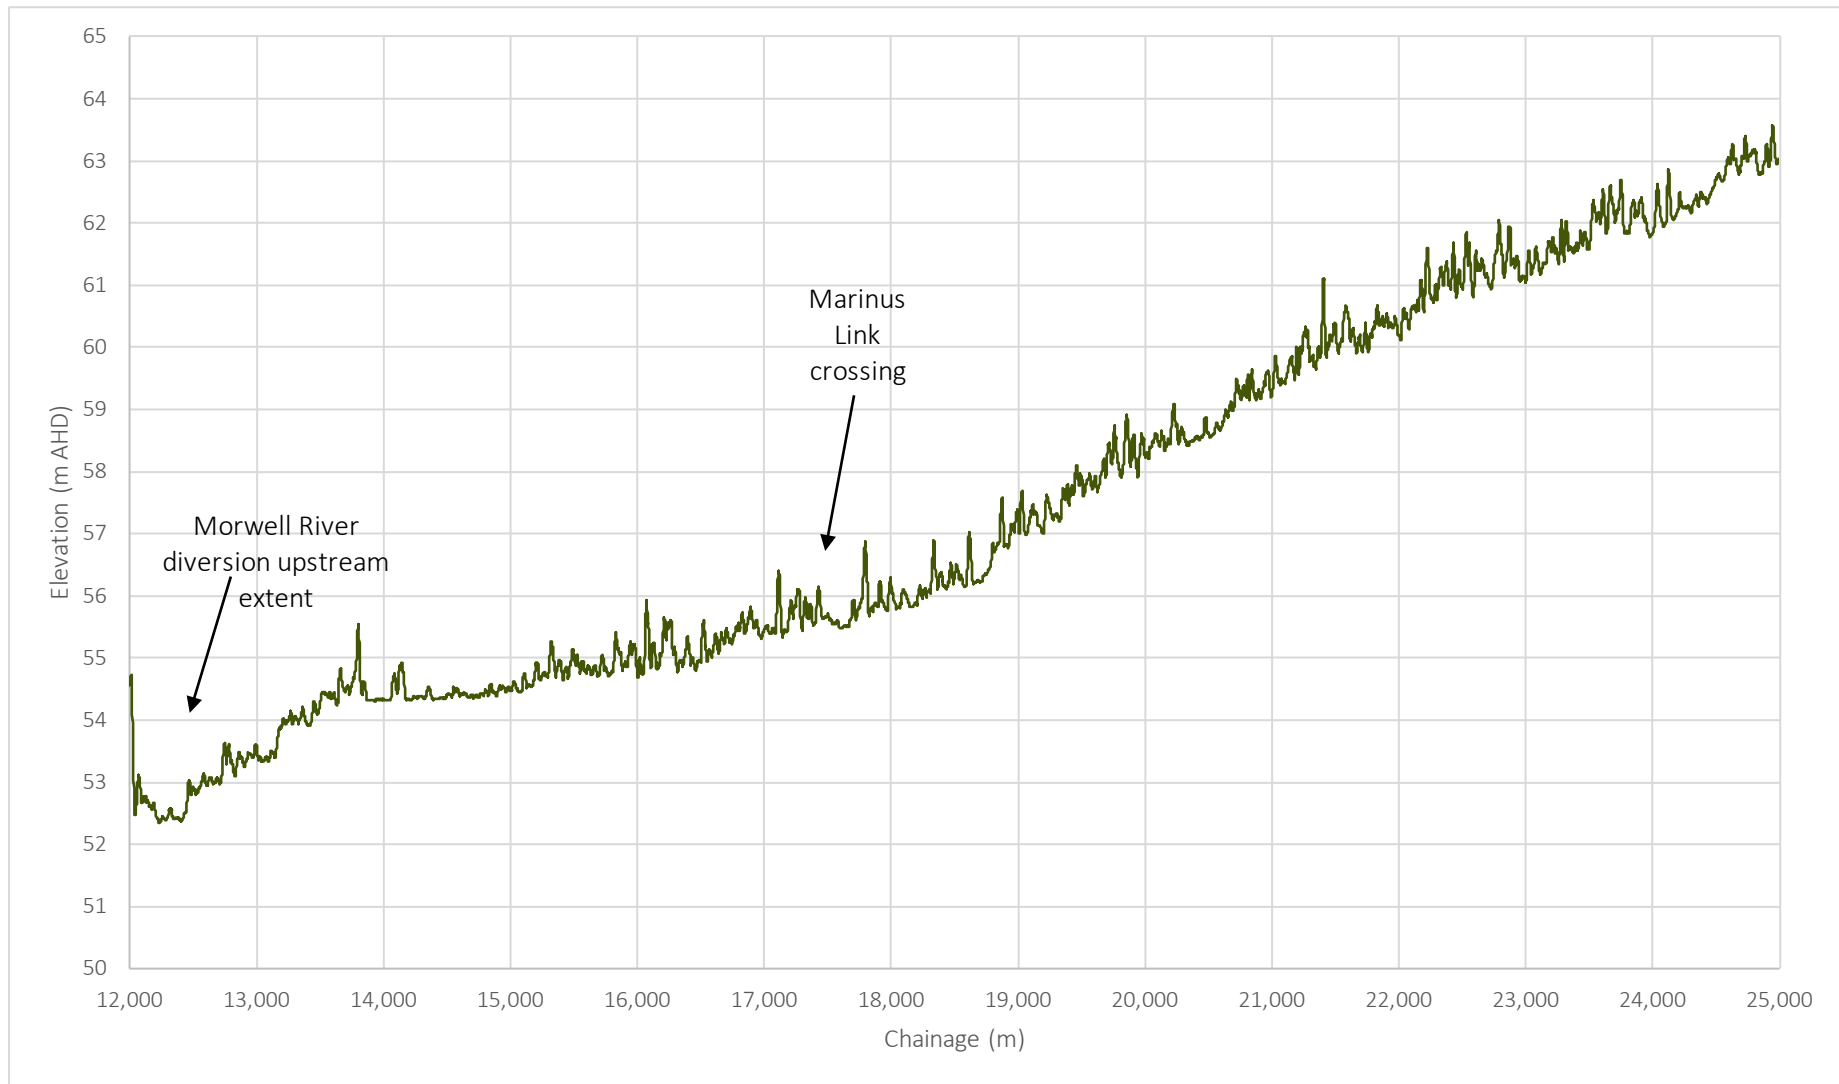
Figure 64. Smoothed longitudinal profile (20-point moving average) of the Morwell River surrounding the proposed project alignment, derived from LiDAR (2010) along ISC centreline alignment.

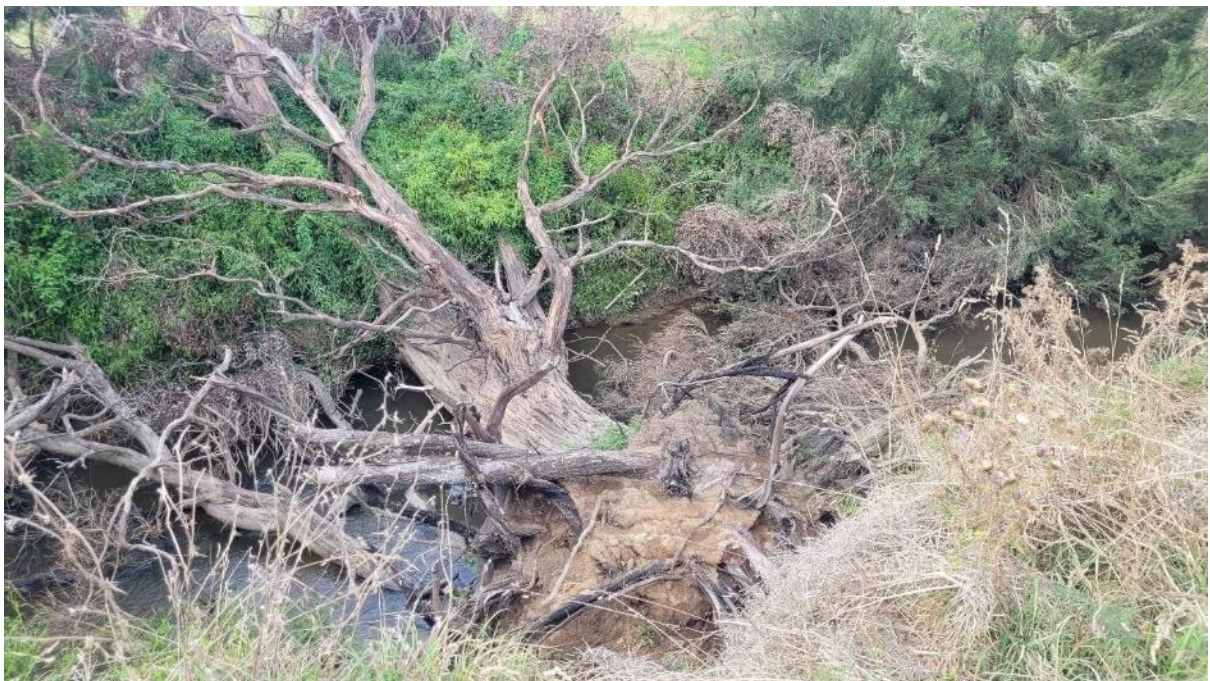
Figure 67. *Morwell River in the vicinity of the proposed project alignment crossing showing recent collapse of trees resulting from erosion/undercutting.*

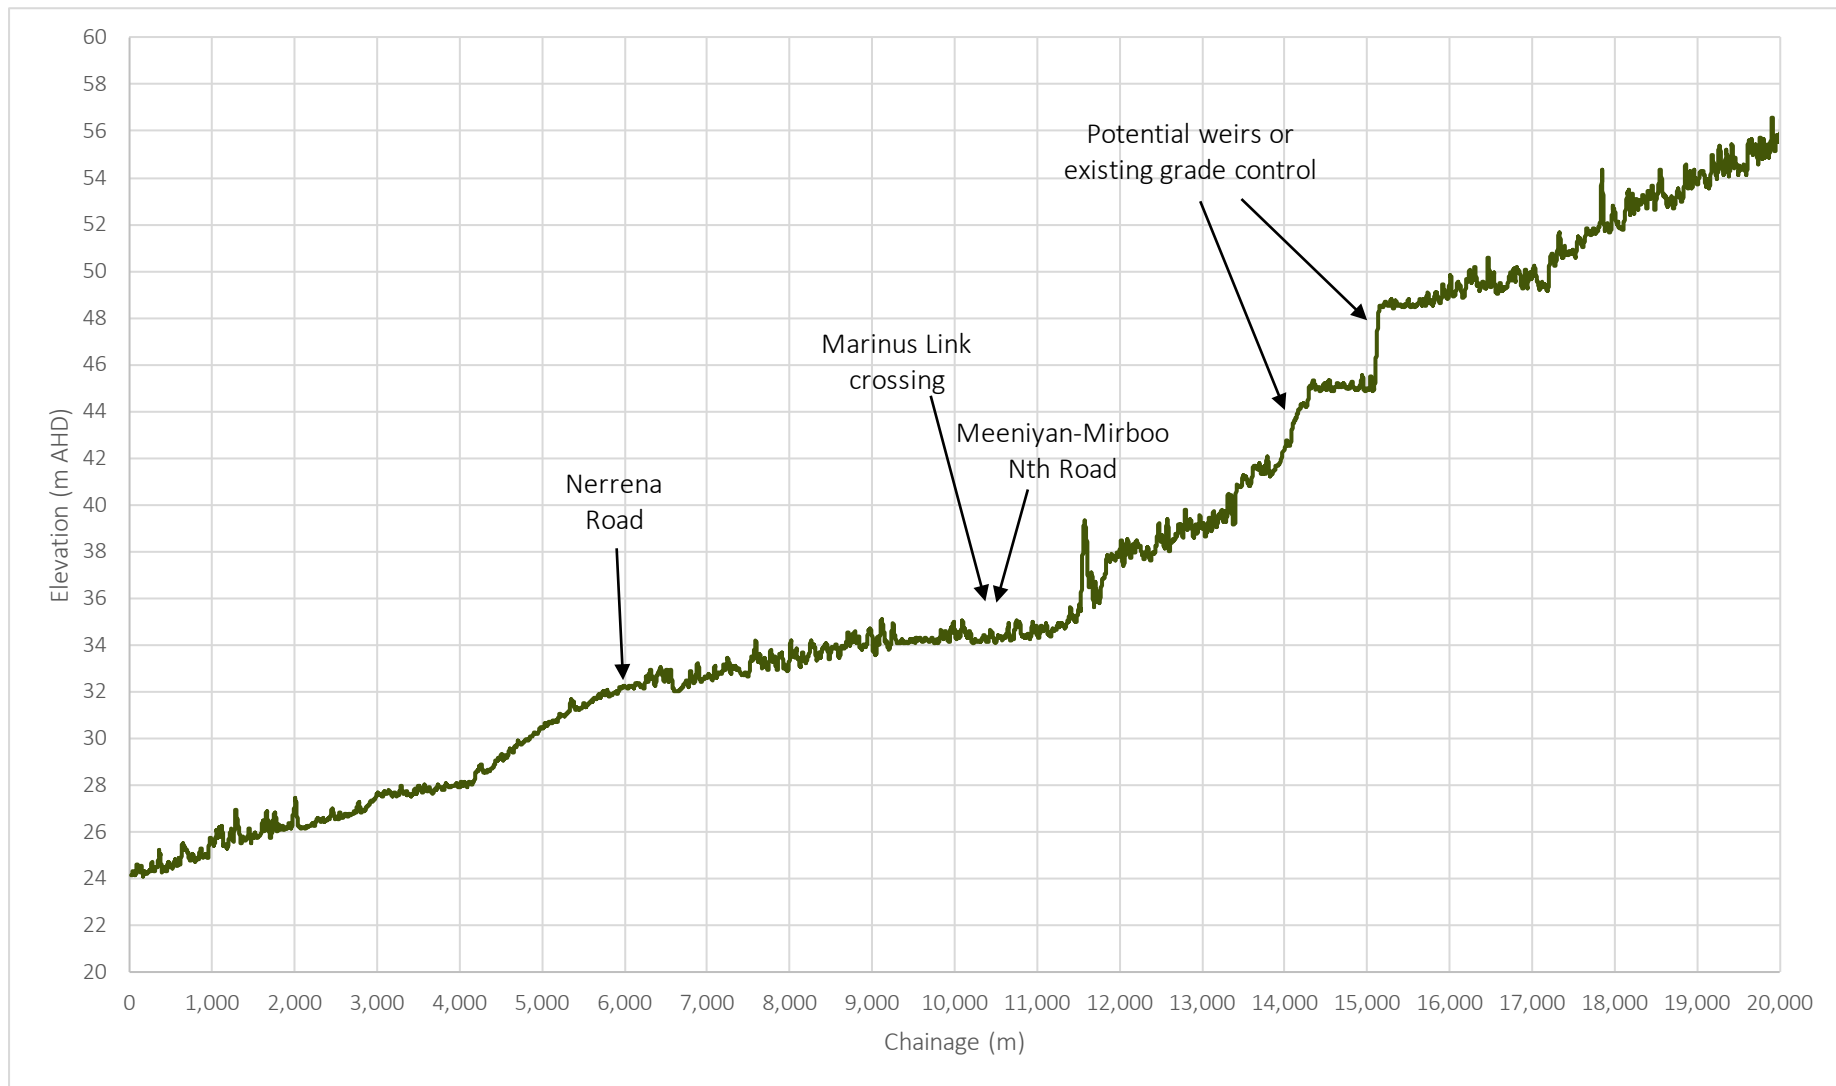
Figure 83. Smoothed longitudinal profile (20-point moving average) of the Tarwin River East Branch surrounding the proposed project alignment, derived from LiDAR along ISC centreline alignment.

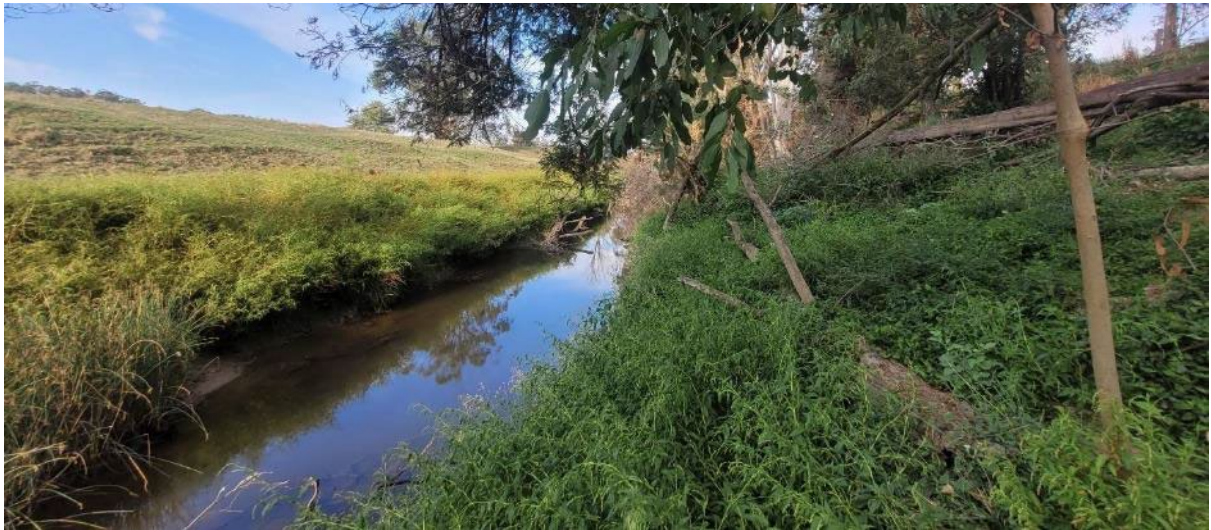
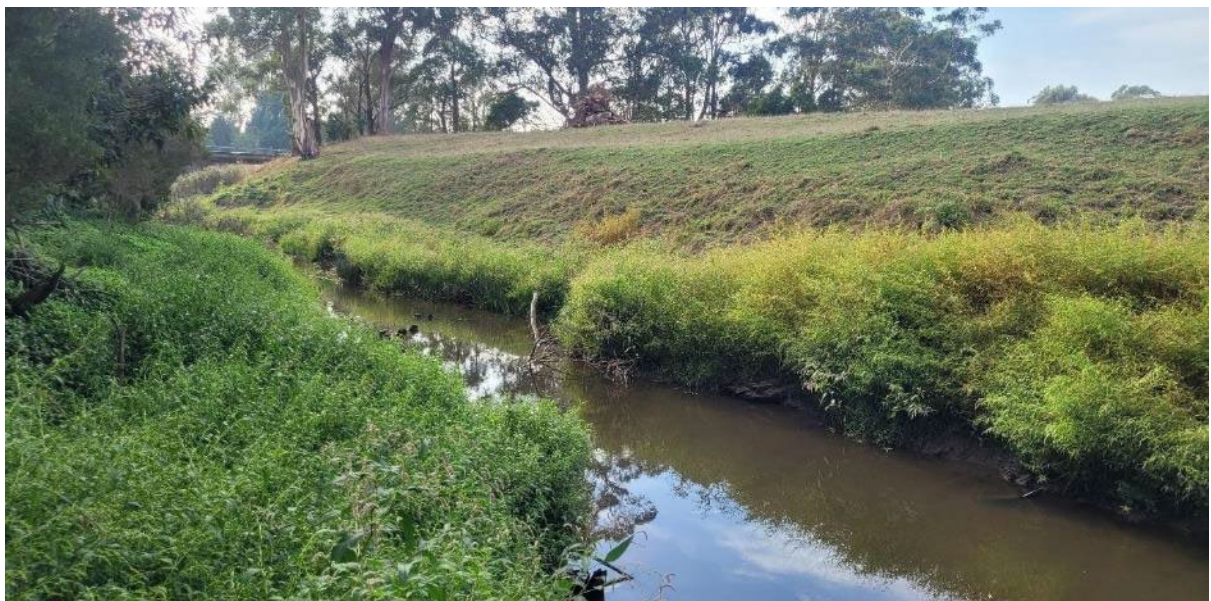
The inspection found that there was no evidence of major bank erosion or bed scour (Figure 85). The right bank (looking downstream) was characterised by coarse woody debris, with recent high wind events and storms leaving these scattered through the right bank zone between the channel and the fence line. The site inspection also revealed flood debris upstream of the proposed project alignment at the bridge crossing on Meeniyan-Mirboo North Road (Figure 86). The bridge piers appeared to be in working order, with no evidence of incision or exposure below their abutments. Although riparian vegetation was sparse, there was no evidence of bank erosion, with established ground cover to the toe of the banks. On the right bank (looking downstream) vegetation was more established with some remnant trees and shrubs, while on the left bank, vegetation comprised of only phragmites and other ground cover species.

Figure 85. *Tarwin River East Branch in the vicinity of the proposed project crossing looking downstream (top) and upstream (bottom)*

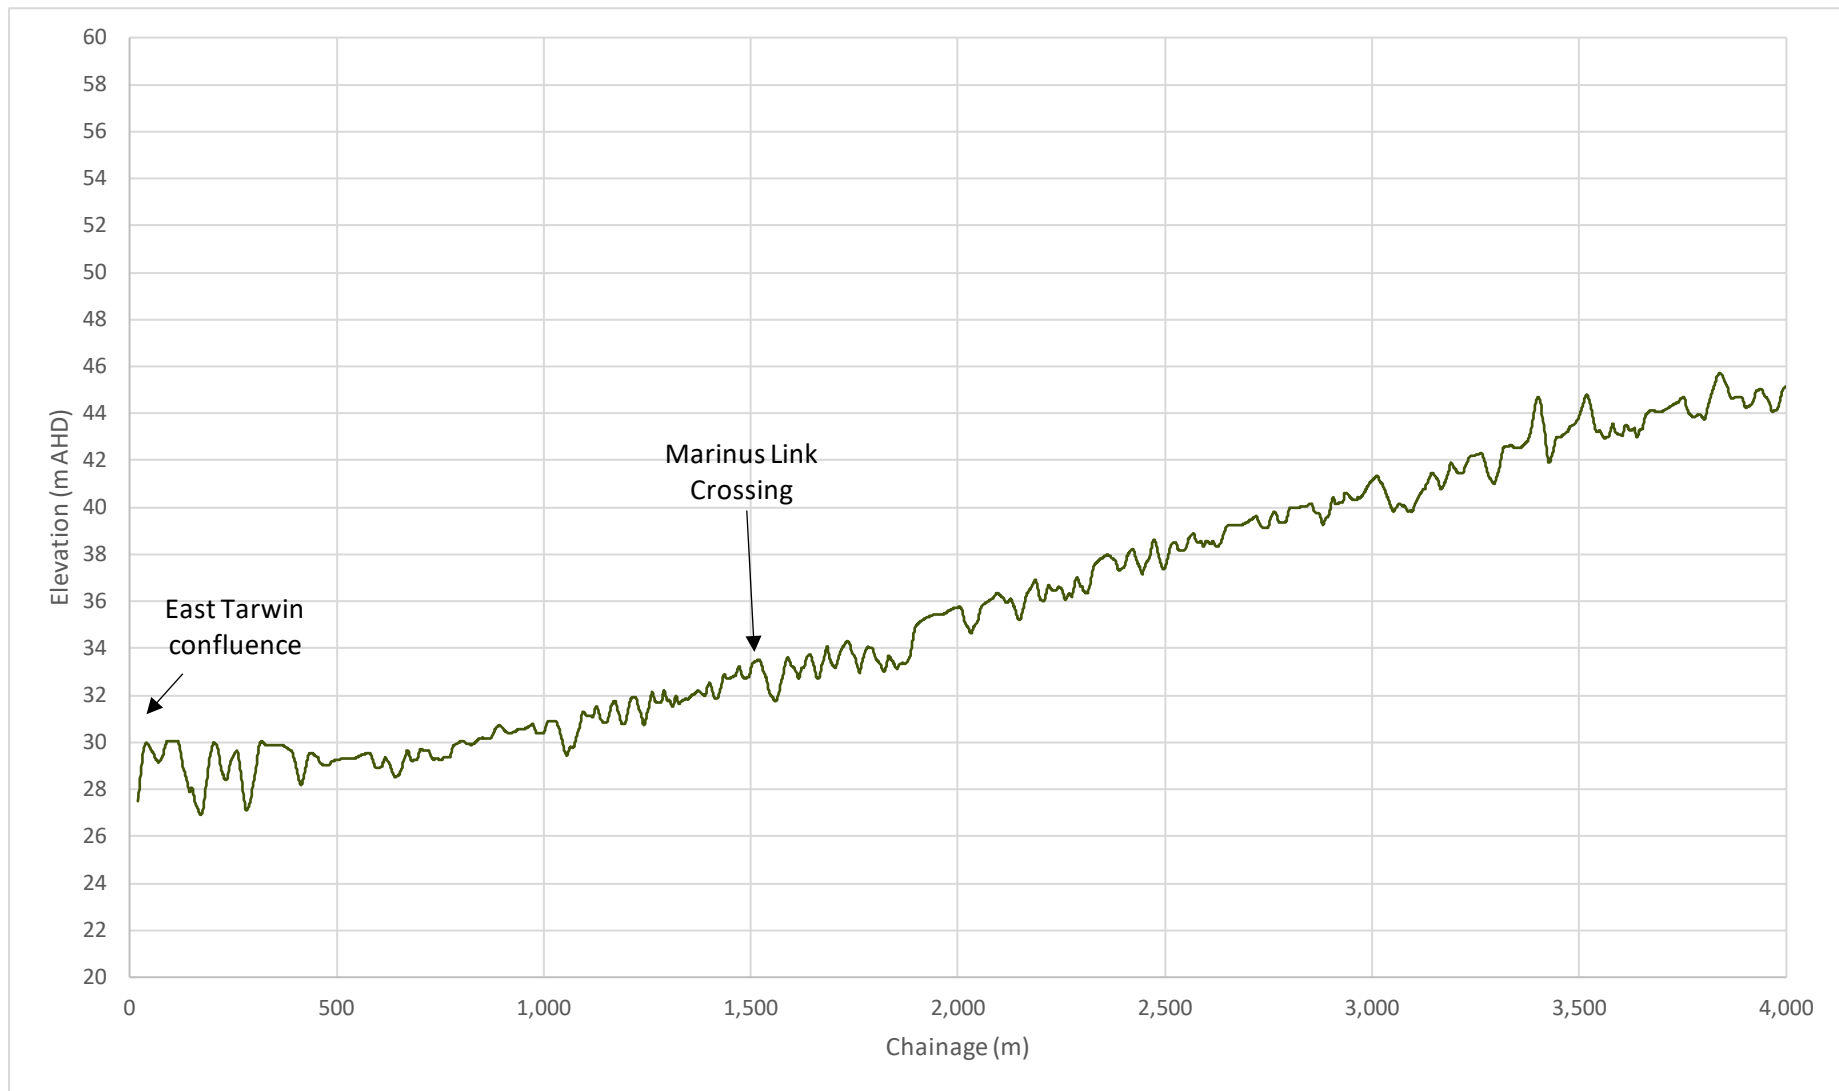
Figure 96. Smoothed longitudinal profile (20-point moving average) of the northern tributary of the Tarwin River East Branch surrounding the proposed project alignment, derived from LiDAR along State waterway alignment.

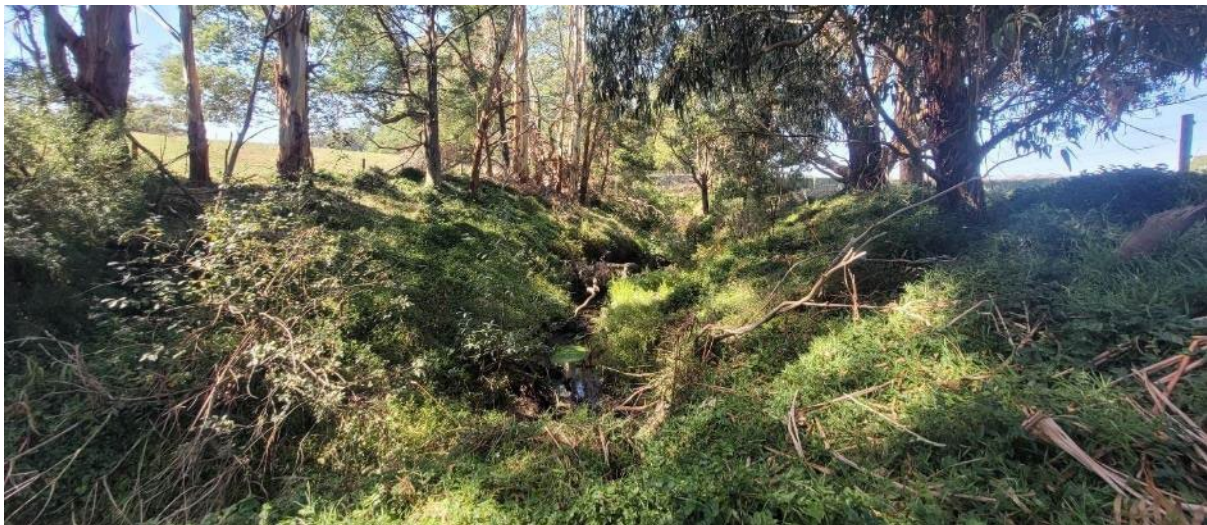
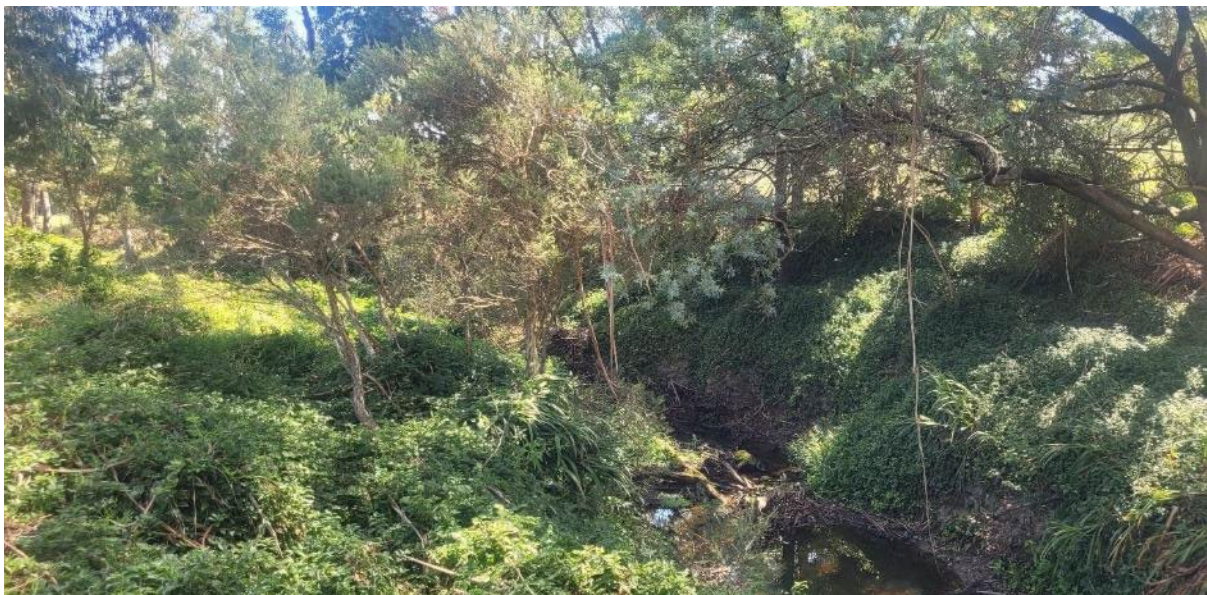
The inspection found that banks appeared stable with no signs of erosion or incision (Figure 107). Banks were well-vegetated with trees, shrubs, and ground cover. The stream was fenced at top of bank with little riparian buffer, but no apparent stock access. Some large wood was seen in the river after recent high wind events/storms, which could promote bank erosion in the vicinity of fallen timber as water attempts to outflank the obstruction. Anecdotes from landholders suggested that in flood events water escapes the channel and travels in a southerly direction over the floodplain. There were no signs of active floodplain scour or obvious breakout point, with dense vegetation cover, making a reach-scale avulsion unlikely.

Figure 107. Stony Creek in the vicinity of the proposed project alignment looking upstream (top) and downstream (bottom).

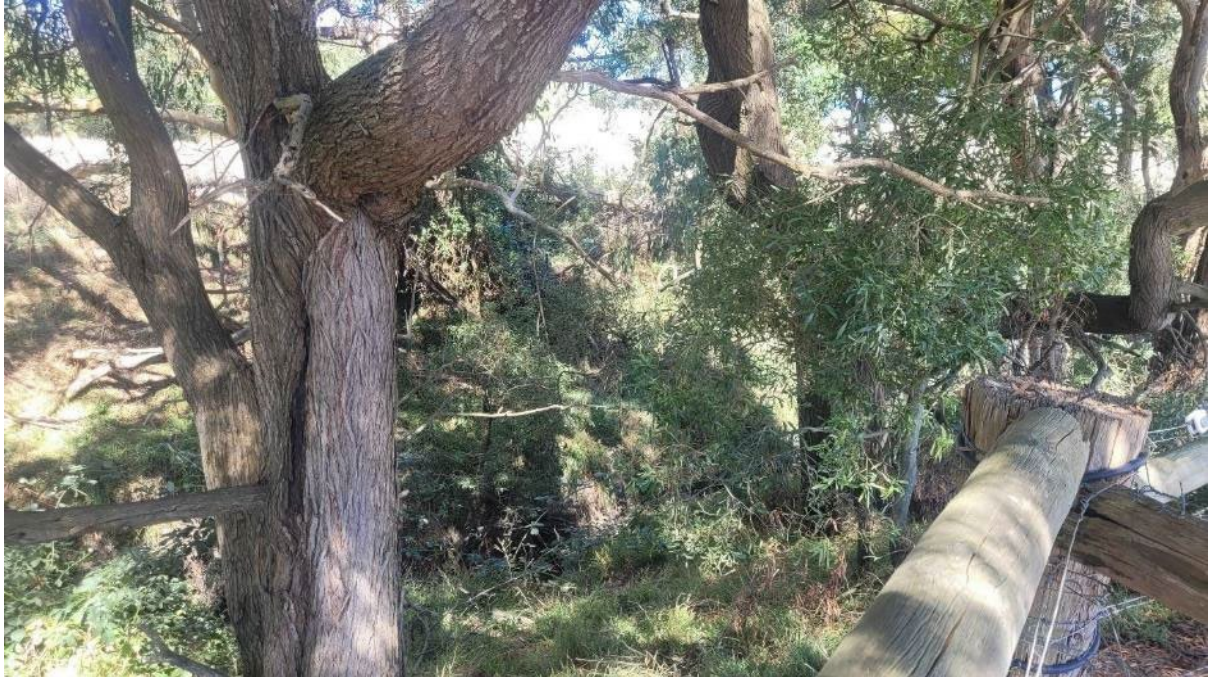
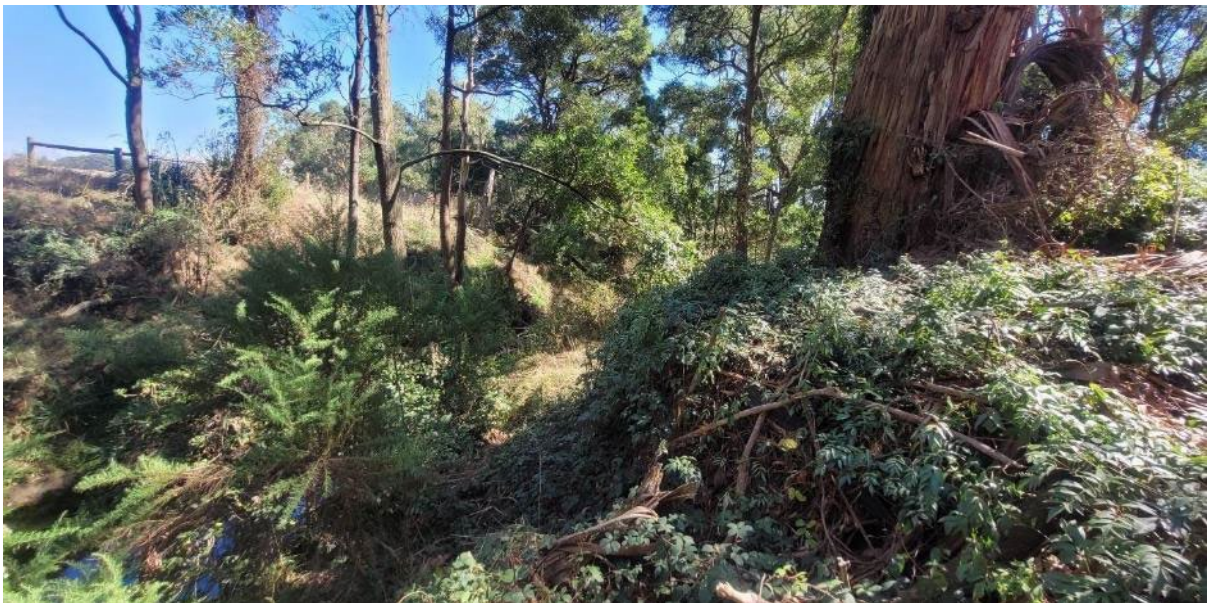
Figure 116. Buffalo Creek in the vicinity of the proposed project alignment from fence at top of bank (top) and from the rail trail culvert looking downstream (bottom)

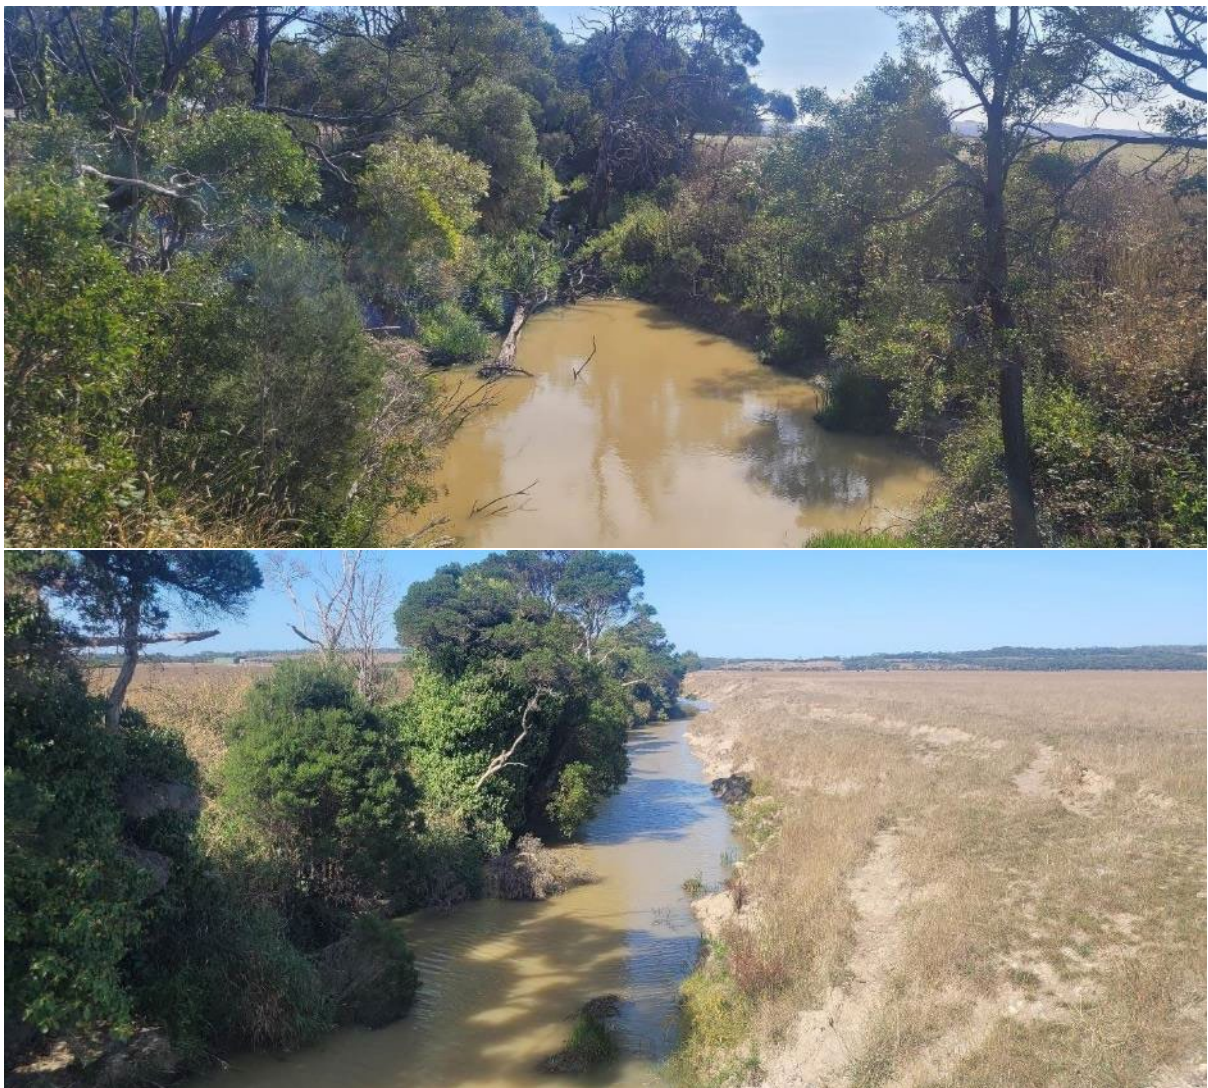
Figure 126. Fish Creek at Buffalo-Waratah Road, looking downstream from the bridge (top) and looking upstream from the bridge (bottom). Note little to no vegetation cover and active bank erosion on left bank (right of bottom photo).
