Ground Conditions Factual Report

Document no: IS360318-SO18-CG-RPT-0006
Revision no: B

Project Marinus - Heybridge Converter Station Ground Investigation
29 April 2022

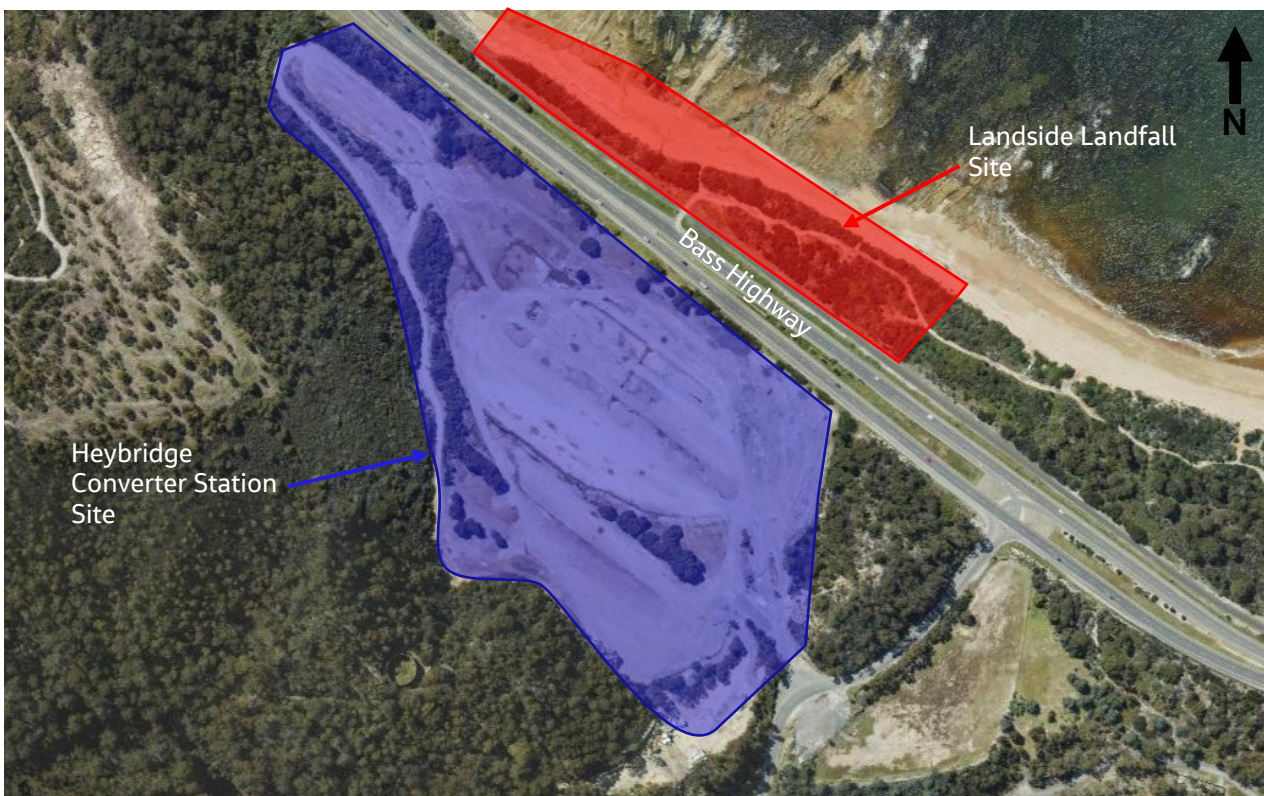
Figure 1-1. Heybridge Converter Station and Landside Landfall Sites (State of Tasmania, Maxar 2022).

The site is in Heybridge, Tasmania, approximately 8 km east of the Township of Burnie. Figure 1-1 shows the extents at which ground investigations were undertaken as part of this report.

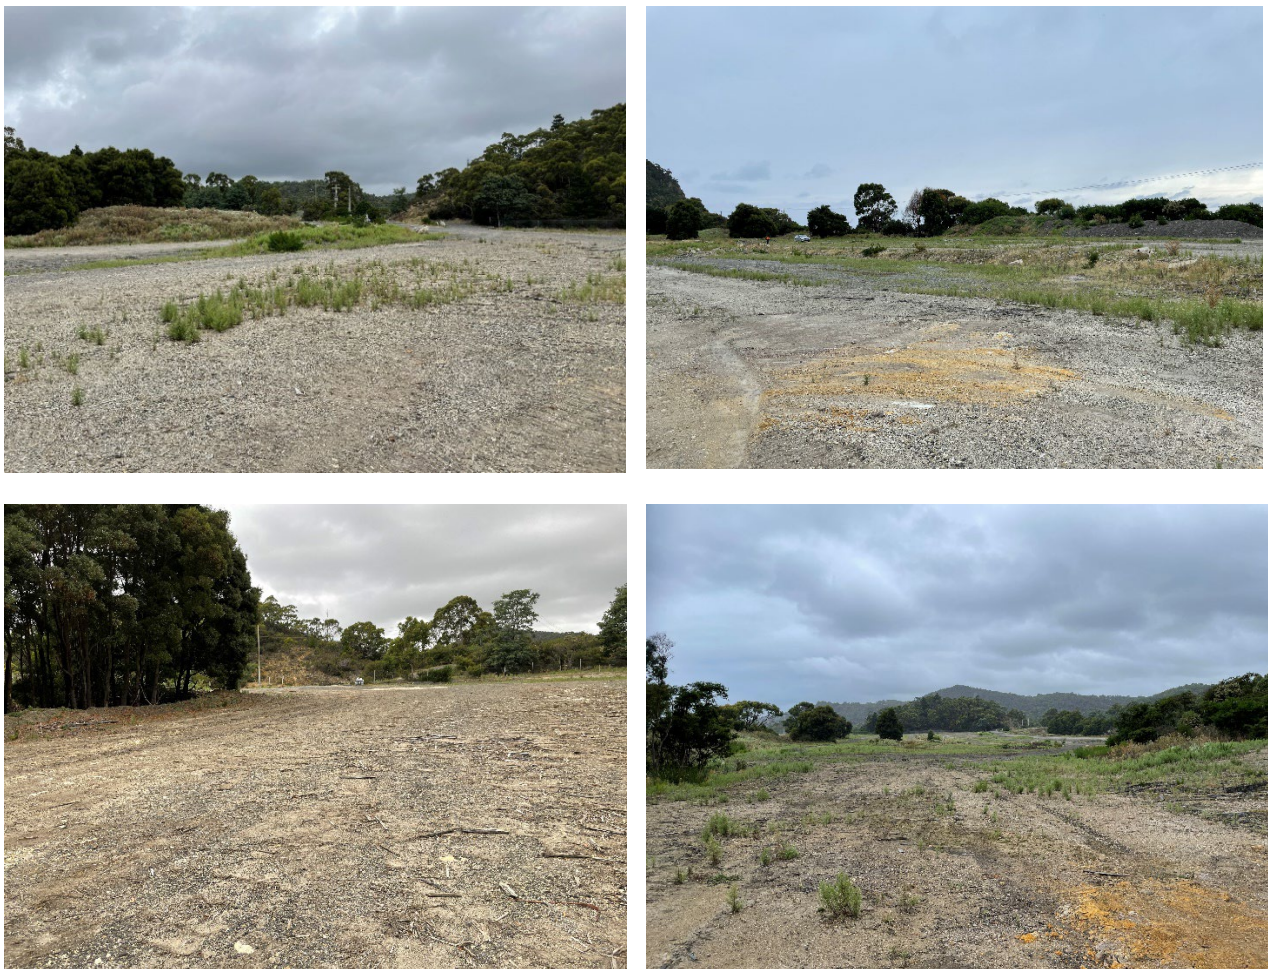
Figure 2-1. General Site Photos - Heybridge Converter Station Site.

The converter station site is currently vacant and is known as the former Tioxide Factory site, as it was previously used as a Tioxide (paint) factory and a lumber yard. There is significant history of disturbance and known contamination present at the site due to its previous land use, including naturally occurring radioactive materials (NORM). Remnants of the old paint factory such as concrete footings and reinforcement is observed within majority of the site extents.

As noted above the proposed Heybridge Converter Station site is located approximately 8km east of Burnie along the Bass Highway. Vehicular access to the site is gained through Minna Road, Heybridge. The site extent is enclosed by the Bass Highway from the north and Minna Road from the East. The site is fenced off and is not accessible to the public. The northern fence line of the site lies parallel to the Bass Hwy whilst the southern fence line is situated at the toe of a mountainous landscape. A gentle north westerly slope is observed within the overall site. Figure 2-1 shows general site photos of the Heybridge Converter Station Site.

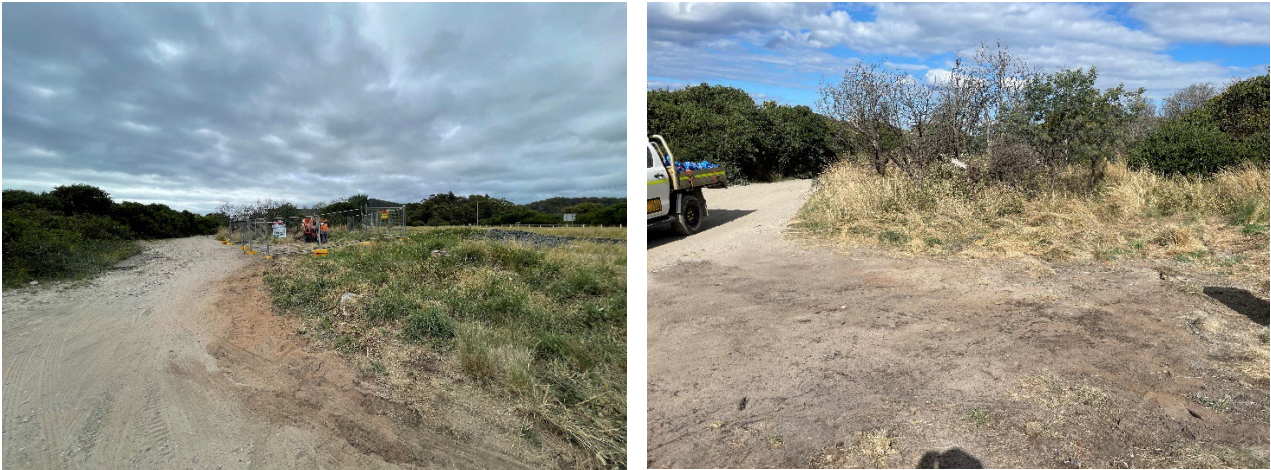
Figure 2-2. General Site Photos - Landside Landfall Site - Location of Borehole HBLF-BH01-C.

The landside landfall site is situated north of the Bass Highway opposite to Heybridge Converter Station Site and south of the Tioxide Beach. Vehicular access to the site is gained from an unsealed access which runs from Bass Highway to Tioxide Beach. The access road also crosses the Western Rail Line Corridor and runs through the whole landfall site extents. The overall area, apart from the access road, is heavily vegetated. In addition, the Tioxide beach and Bass Straight shoreline is considered a nearby sensitive receptor which is approximately 100m from the access road. Figure 2-2 and Figure 2-3 shows the borehole locations HBLF-BH01-C and HBLF-BH02-C at the Landside Landfall Site respectively.

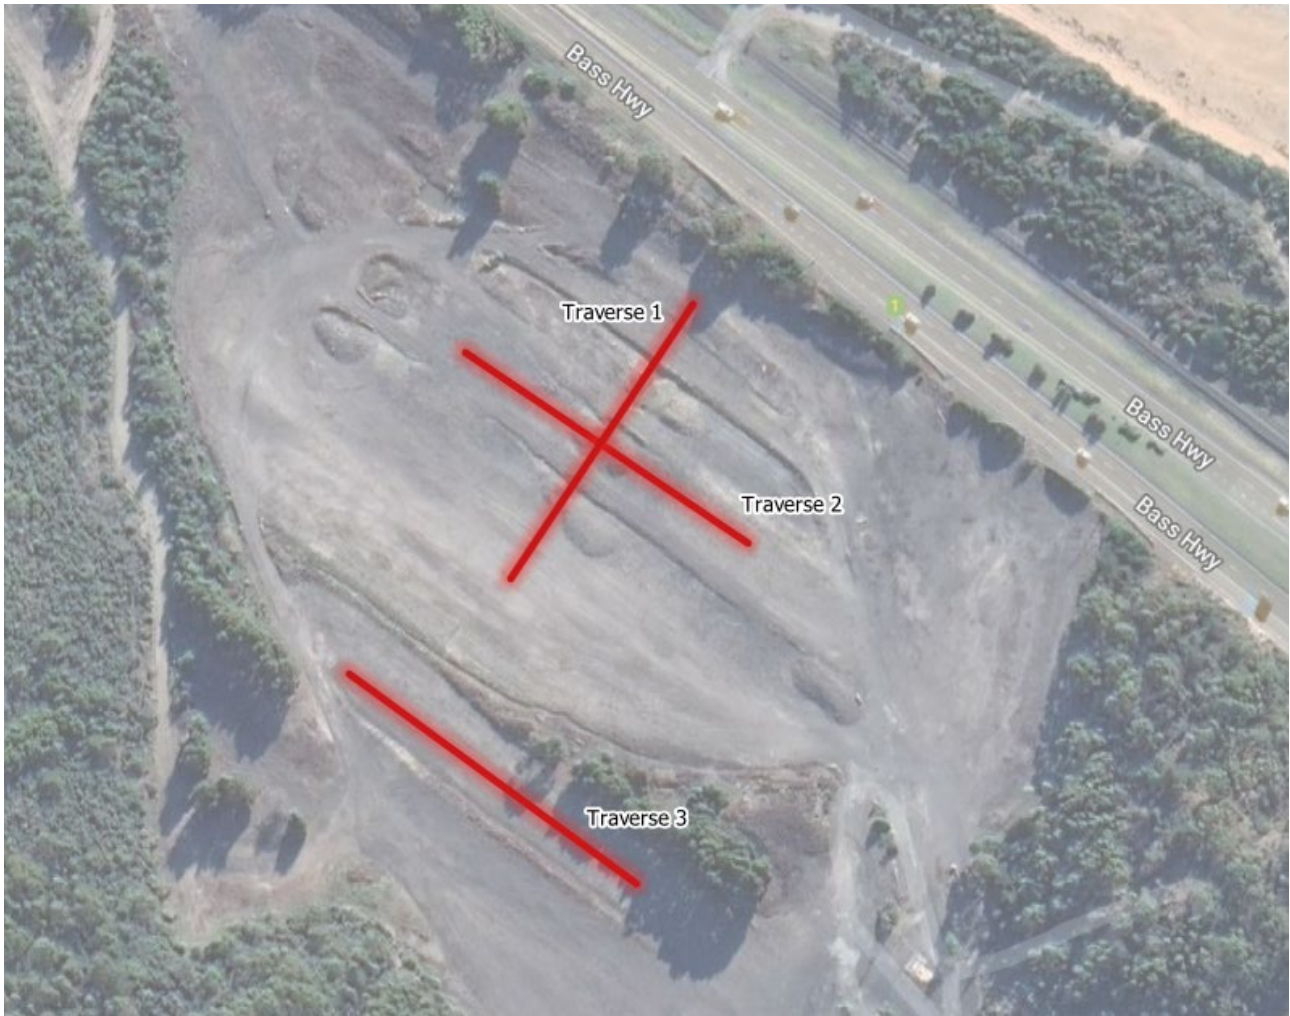
Figure 3-1. Electrical resistivity traverse locations (indicative)

In-situ soil electrical resistivity testing was undertaken by Jacobs engineers for the Heybridge Inverter Station site on 24 January 2022. The soil conditions on the day were dry with a maximum temperature of 23°C. Three traverses were undertaken using the four electrode Wenner method at locations shown indicated in Figure 3-1.

The testing was undertaken by use of the AEMC 6471 with Wenner probe spacings of up to 40 m in a straight line. Refer to Section 4.3 for the test results.

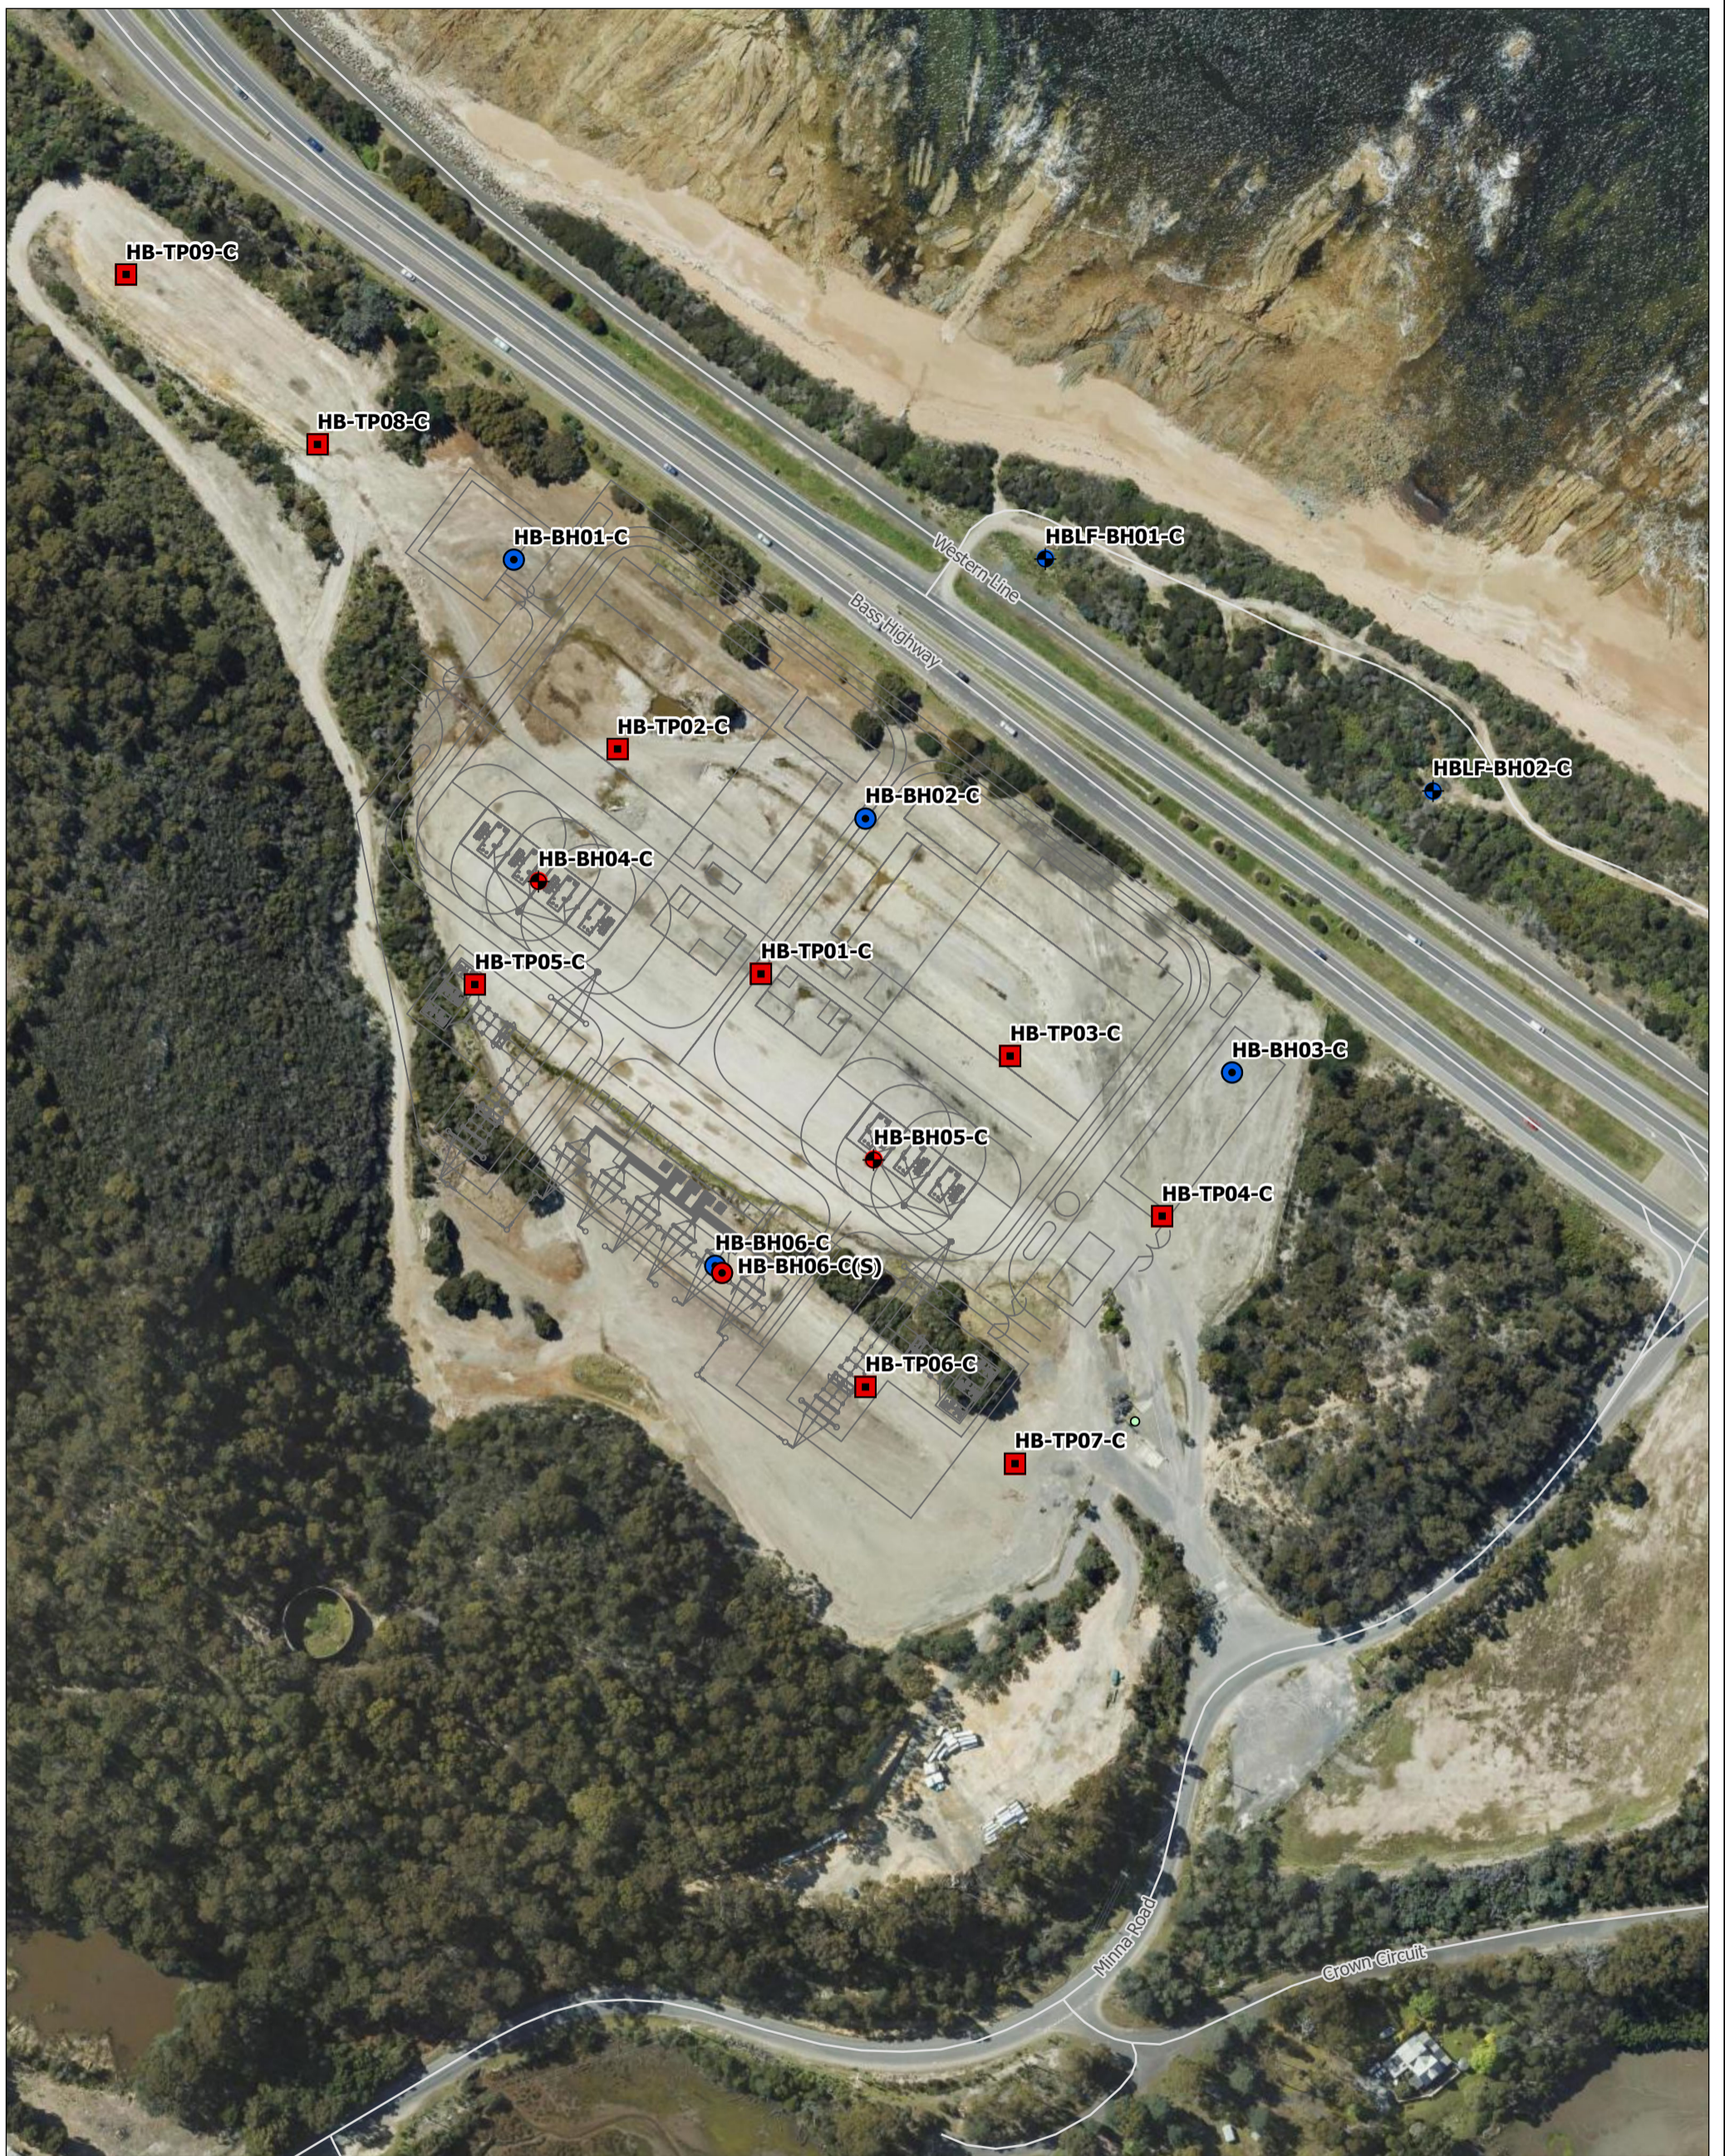
Project Marinus
Fig 1 Site Location Plan

- ◆ Completed Geotechnical and Contaminated Land Borehole
- ◆ Completed Geotechnical Borehole
- Completed Groundwater Well
- Completed Geotechnical and Contaminated Land Borehole/Completed Groundwater Wells
- Completed Geotechnical and Contaminated Land Test Pit

A summary of the boreholes undertaken is provided in Table 3-1. Borehole and the test pit locations are shown in Appendix A. The subsurface conditions encountered at the investigation locations are presented on the borehole and test pit logs provided in Appendix B.
