## **Marinus Link**

# **Contaminated Land and Acid Sulfate Soils Impact Assessment – Heybridge Converter Station, Tasmania**

**Reference: 754-MELEN215878ML\_Sub\_CSASS-Tas\_R01**

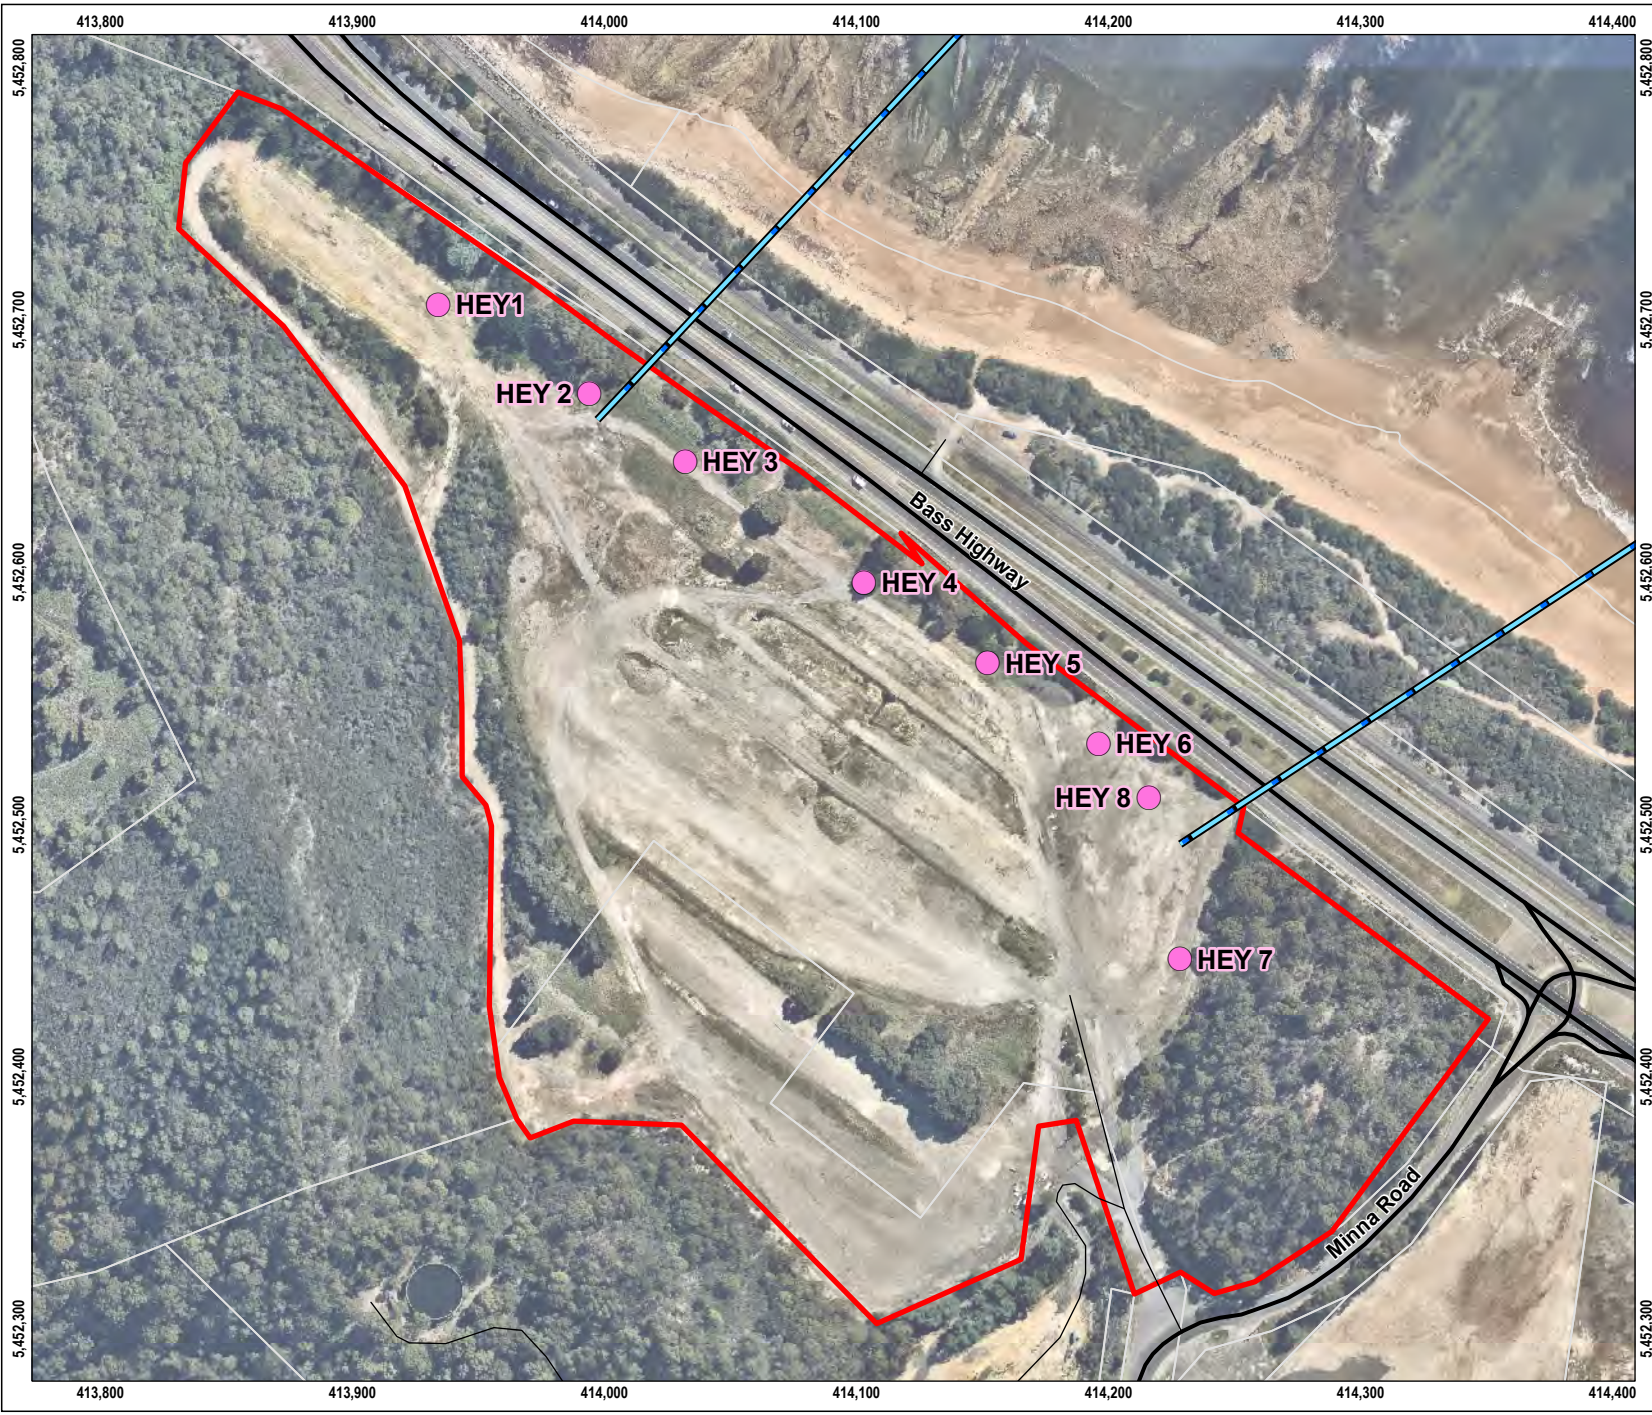
**LEGEND**

- ASS sample location
- Proposed route
- HVDC subsea cable
- Heybridge converter station site boundary
- Major road
- Minor road
- Cadastre

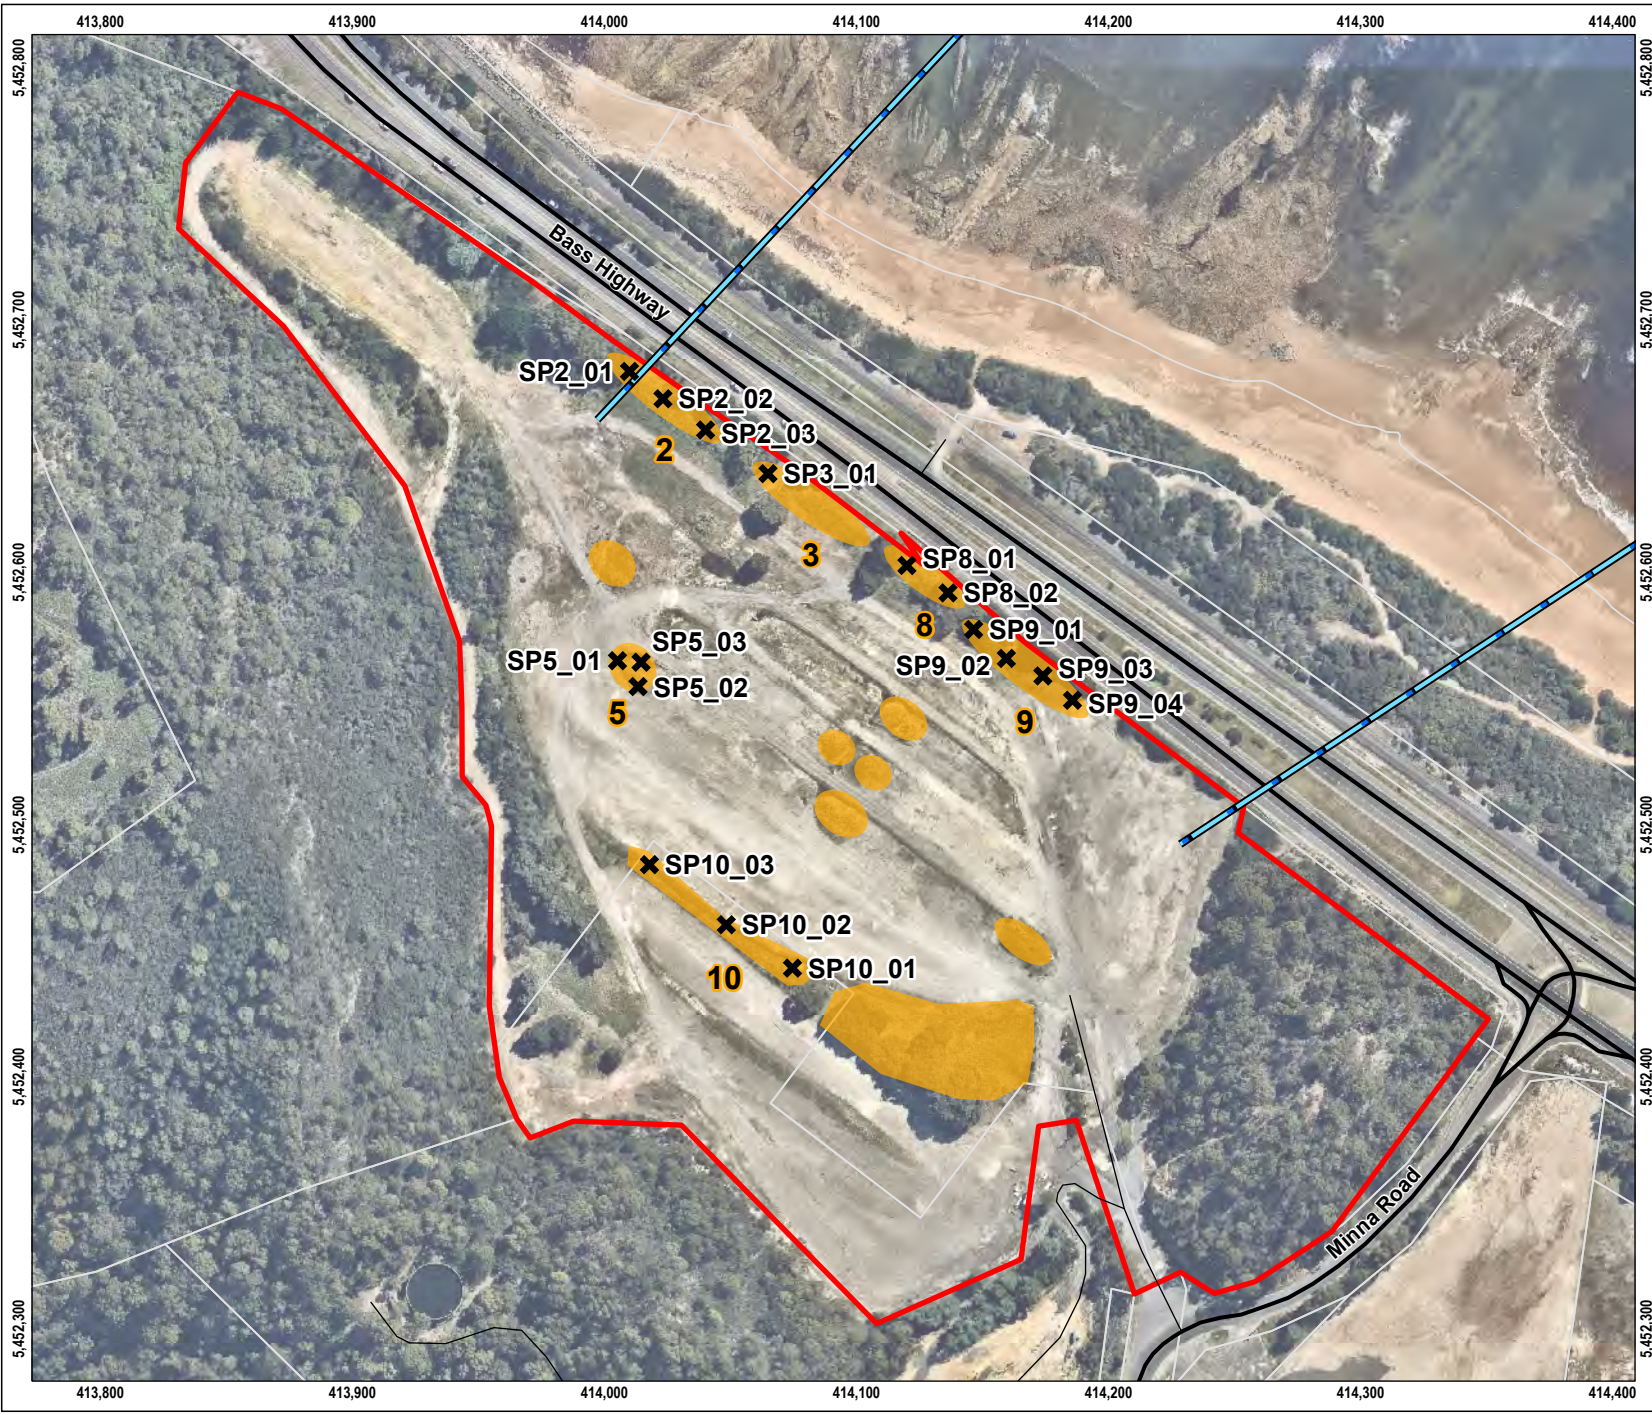
**LEGEND**

- Soil stockpile sample
- Stockpile
- Proposed route
- HVDC subsea cable
- Major road
- Minor road
- Cadastre

Stockpile samples were submitted to NATA accredited laboratories for the following analysis:

- Total Recoverable Hydrocarbons (TRH), benzene, toluene, ethylbenzene, xylene and naphthalene (BTEXN), polycyclic aromatic hydrocarbons (PAH) and metals (As, Cd, Cr, Cu, Ni, Pb, Hg) – 12 samples.
- Tas EPA 105 Screen – 4 samples.

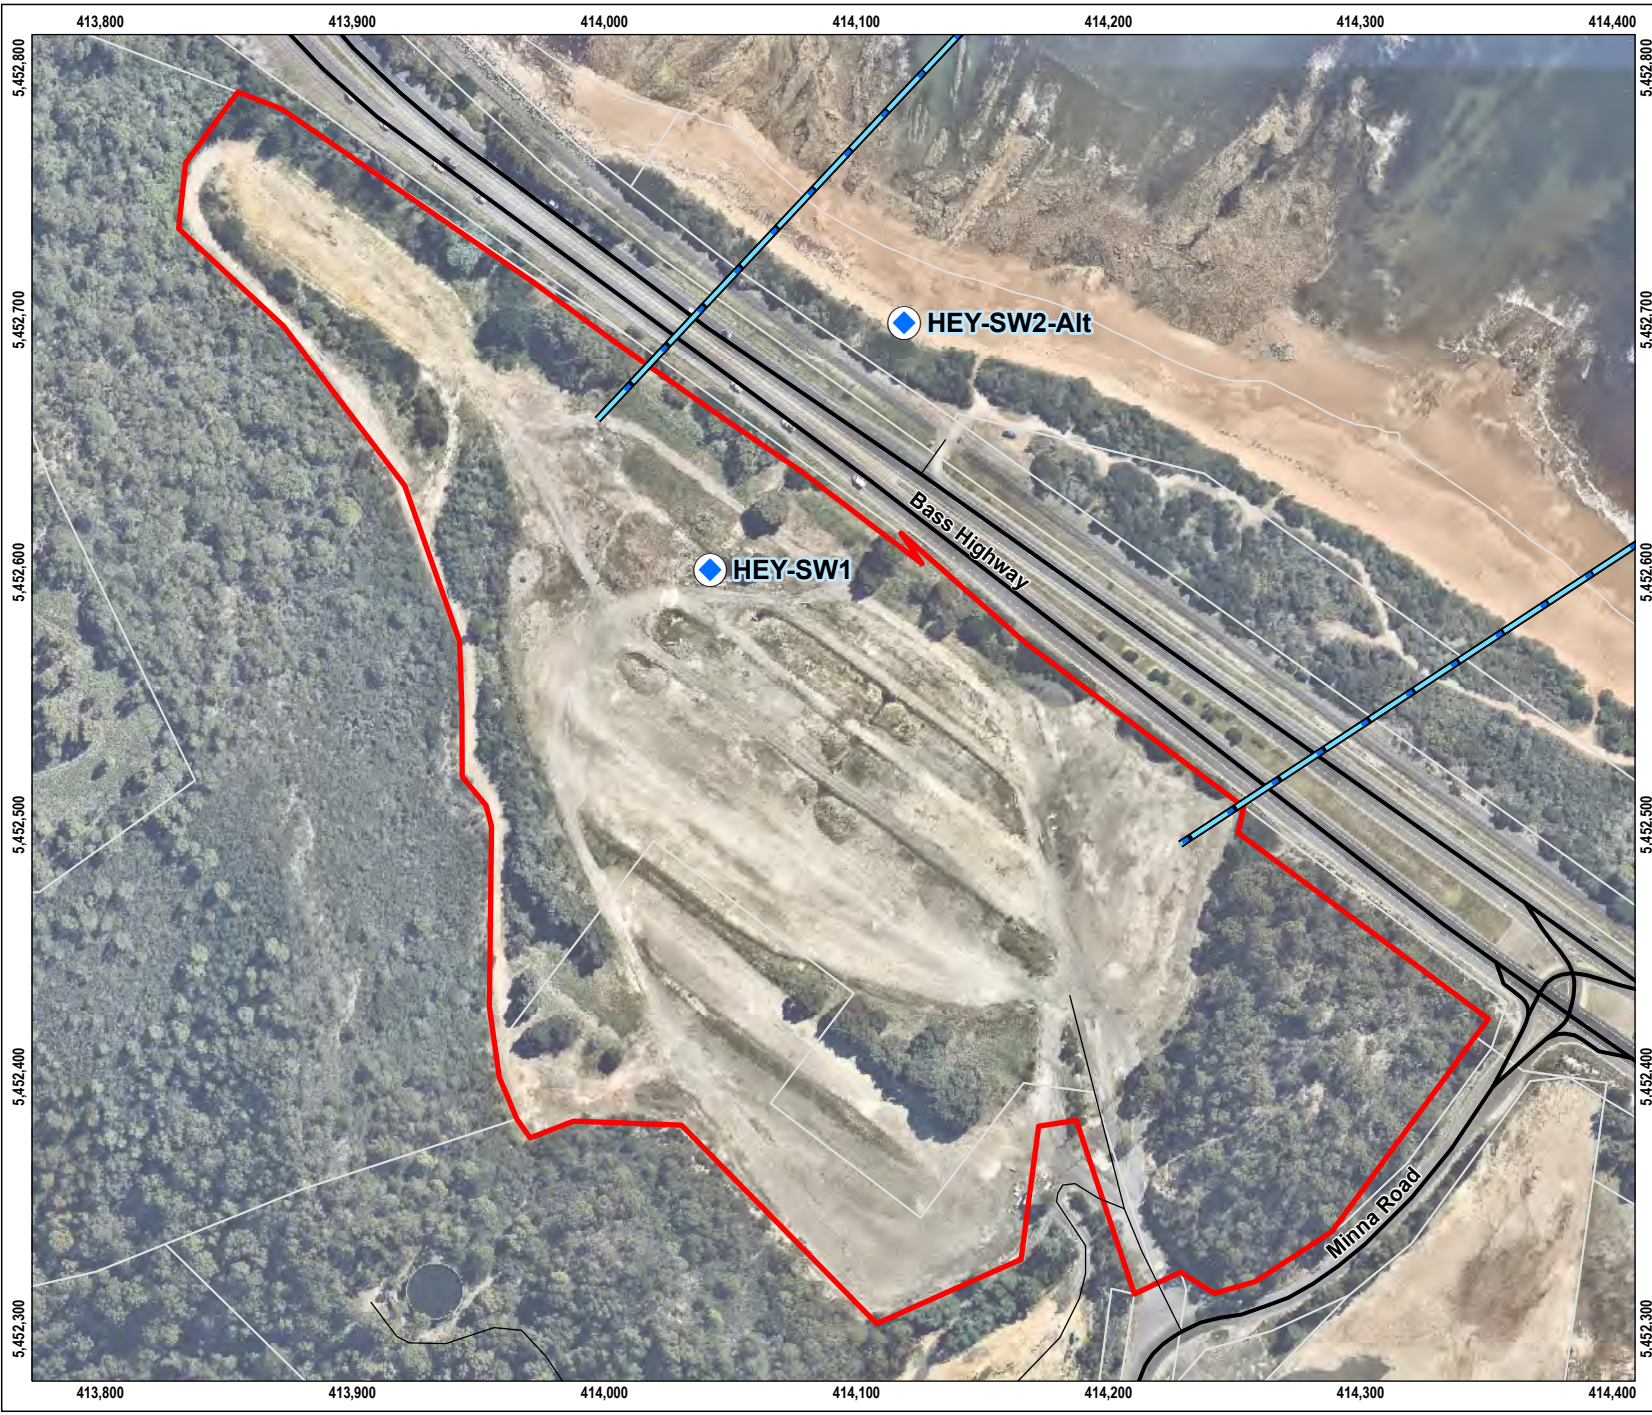
Surface water samples were submitted to NATA accredited laboratories for the following analysis:

- Metals (As, Cd, Cr, Cu, Ni, Pb, Hg, Ag, Sn, Mo, Se, Zn) Cr<sup>6+</sup>
- Total recoverable hydrocarbons (TRH)
- PAH
- Phenols
- OCP
- PCB
- VOCs
- Vinyl chloride

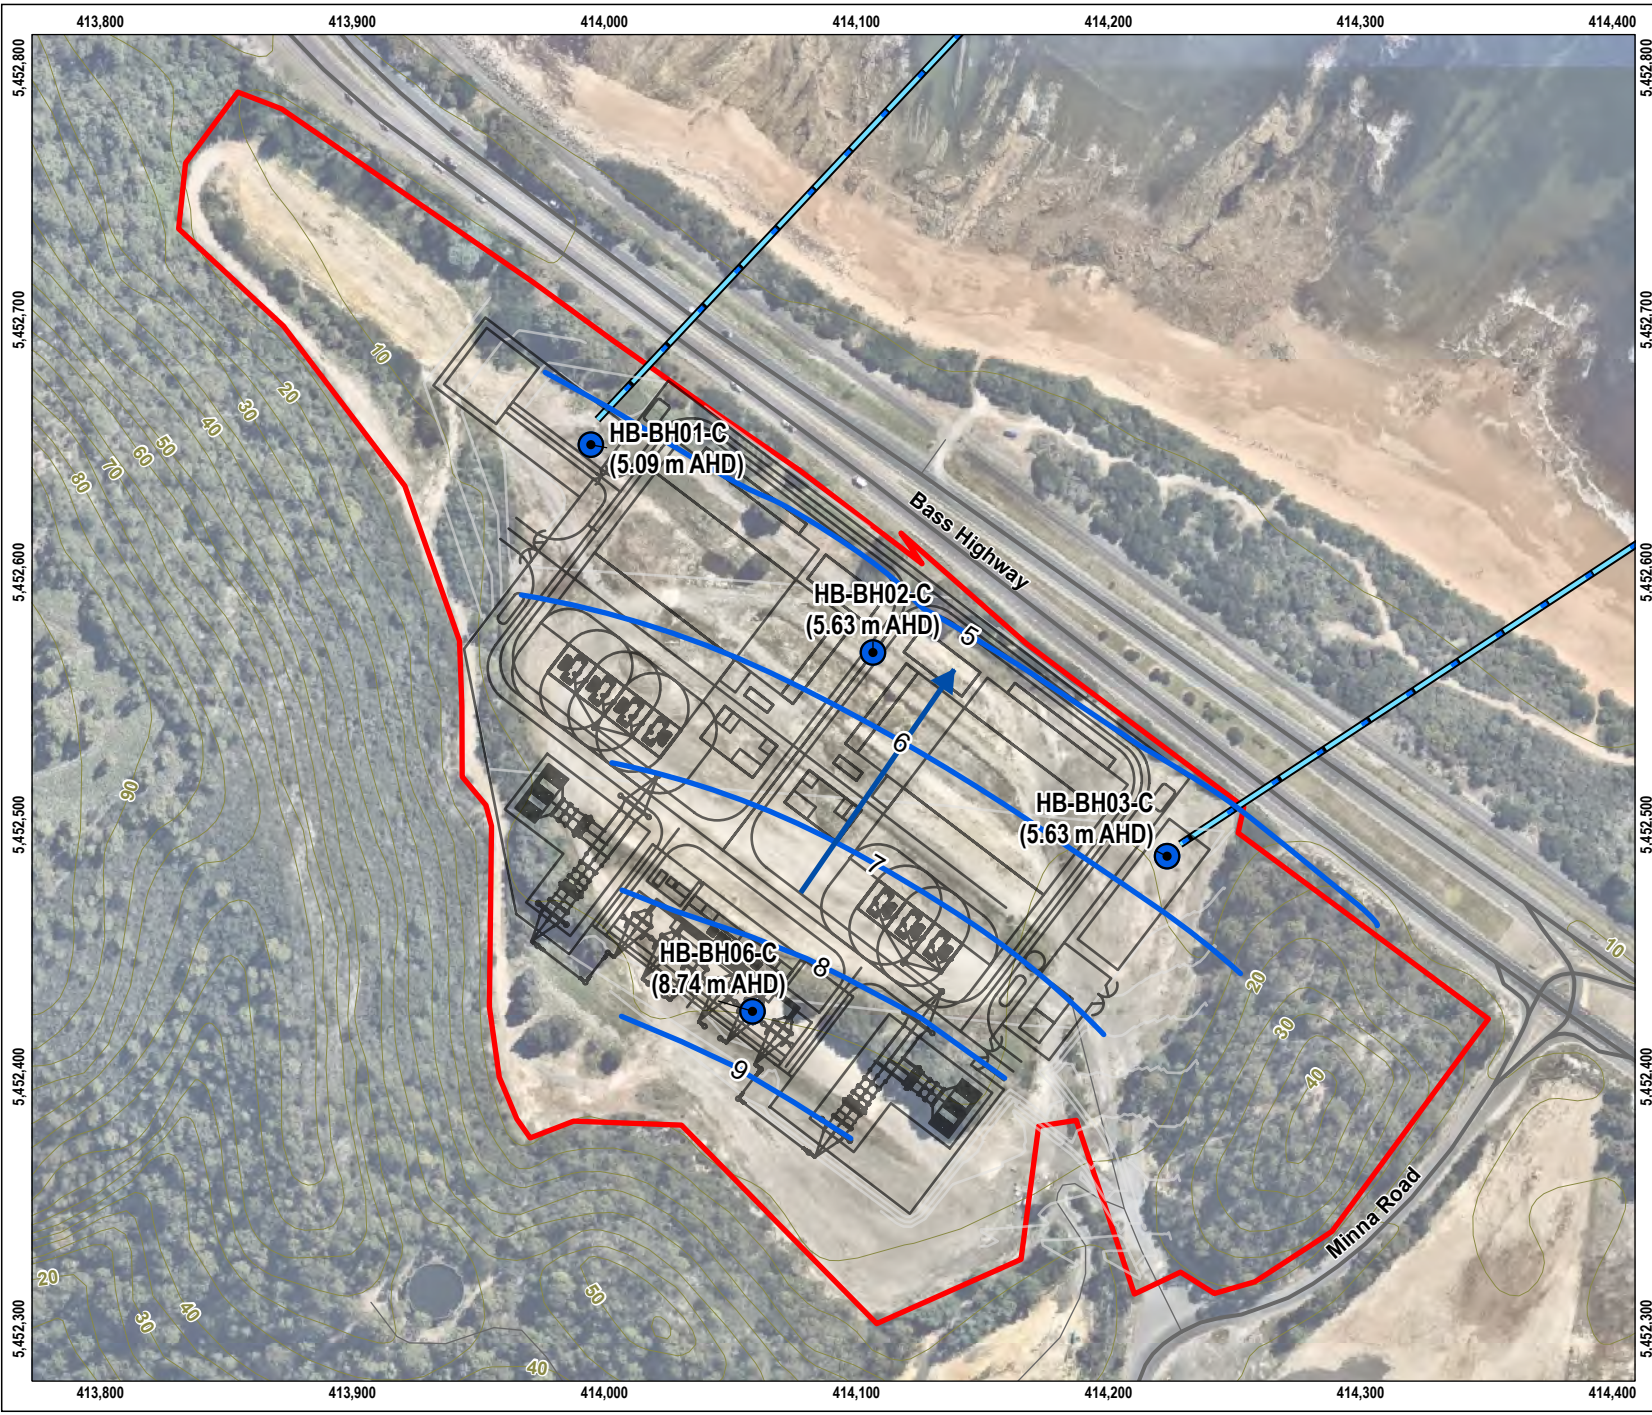
TDS values recorded for groundwater samples historically collected at the study area ranged from 700 to 1,300 mg/L (Cromer, 2007) while Jacobs (2022a) reported electrical conductivity (EC) between 213 and 615  $\mu\text{S}/\text{cm}$  in groundwater sampled from test pits at the site. Groundwater was inferred to flow to the north (Bass Straight) as shown in Figure 10.

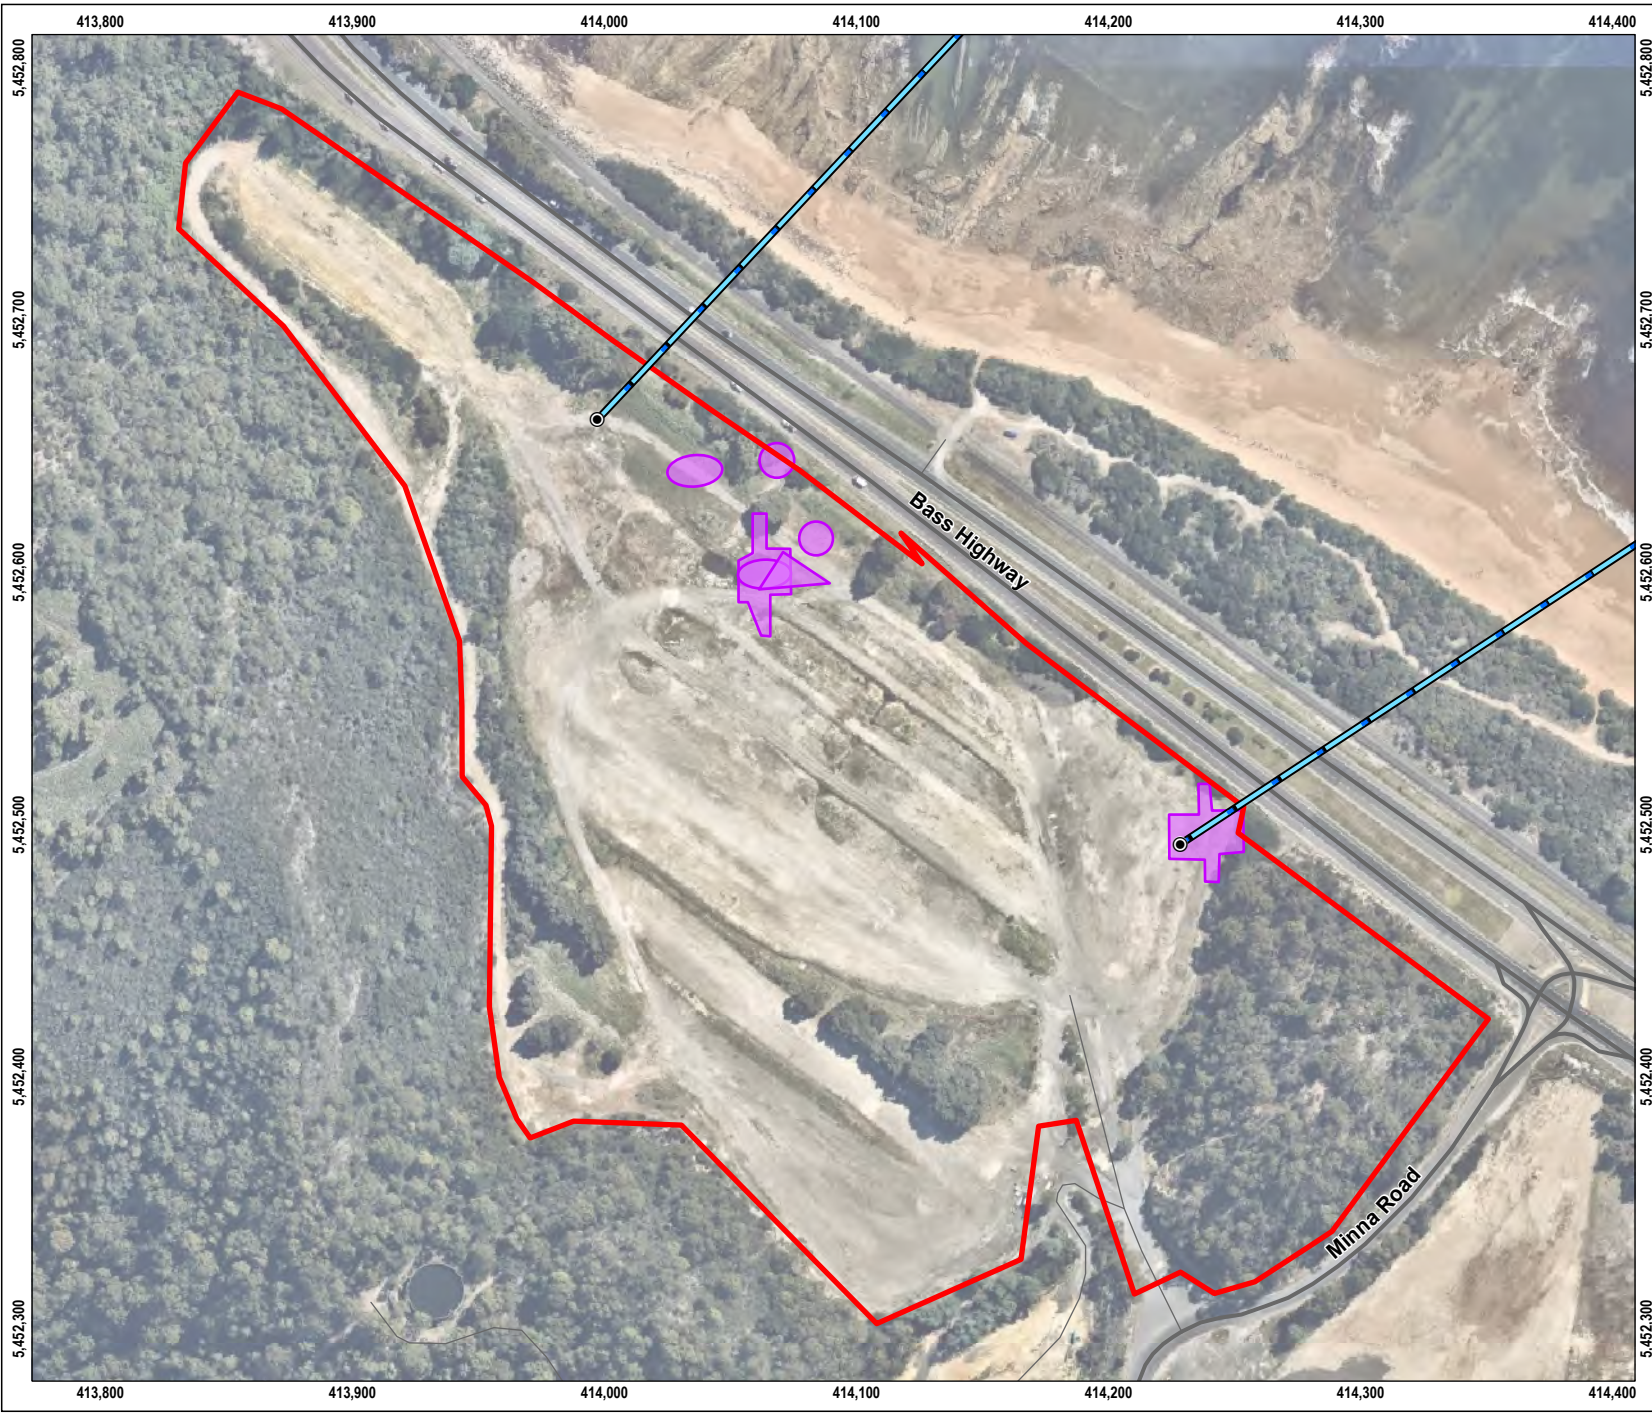
**LEGEND**

- Landfall
- Proposed route
  - HVDC subsea cable
  - ▭ Heybridge converter station site boundary
  - Major road
  - Minor road
  - ▭ Areas where ACM debris was identified and removed from site (approx. locations only)

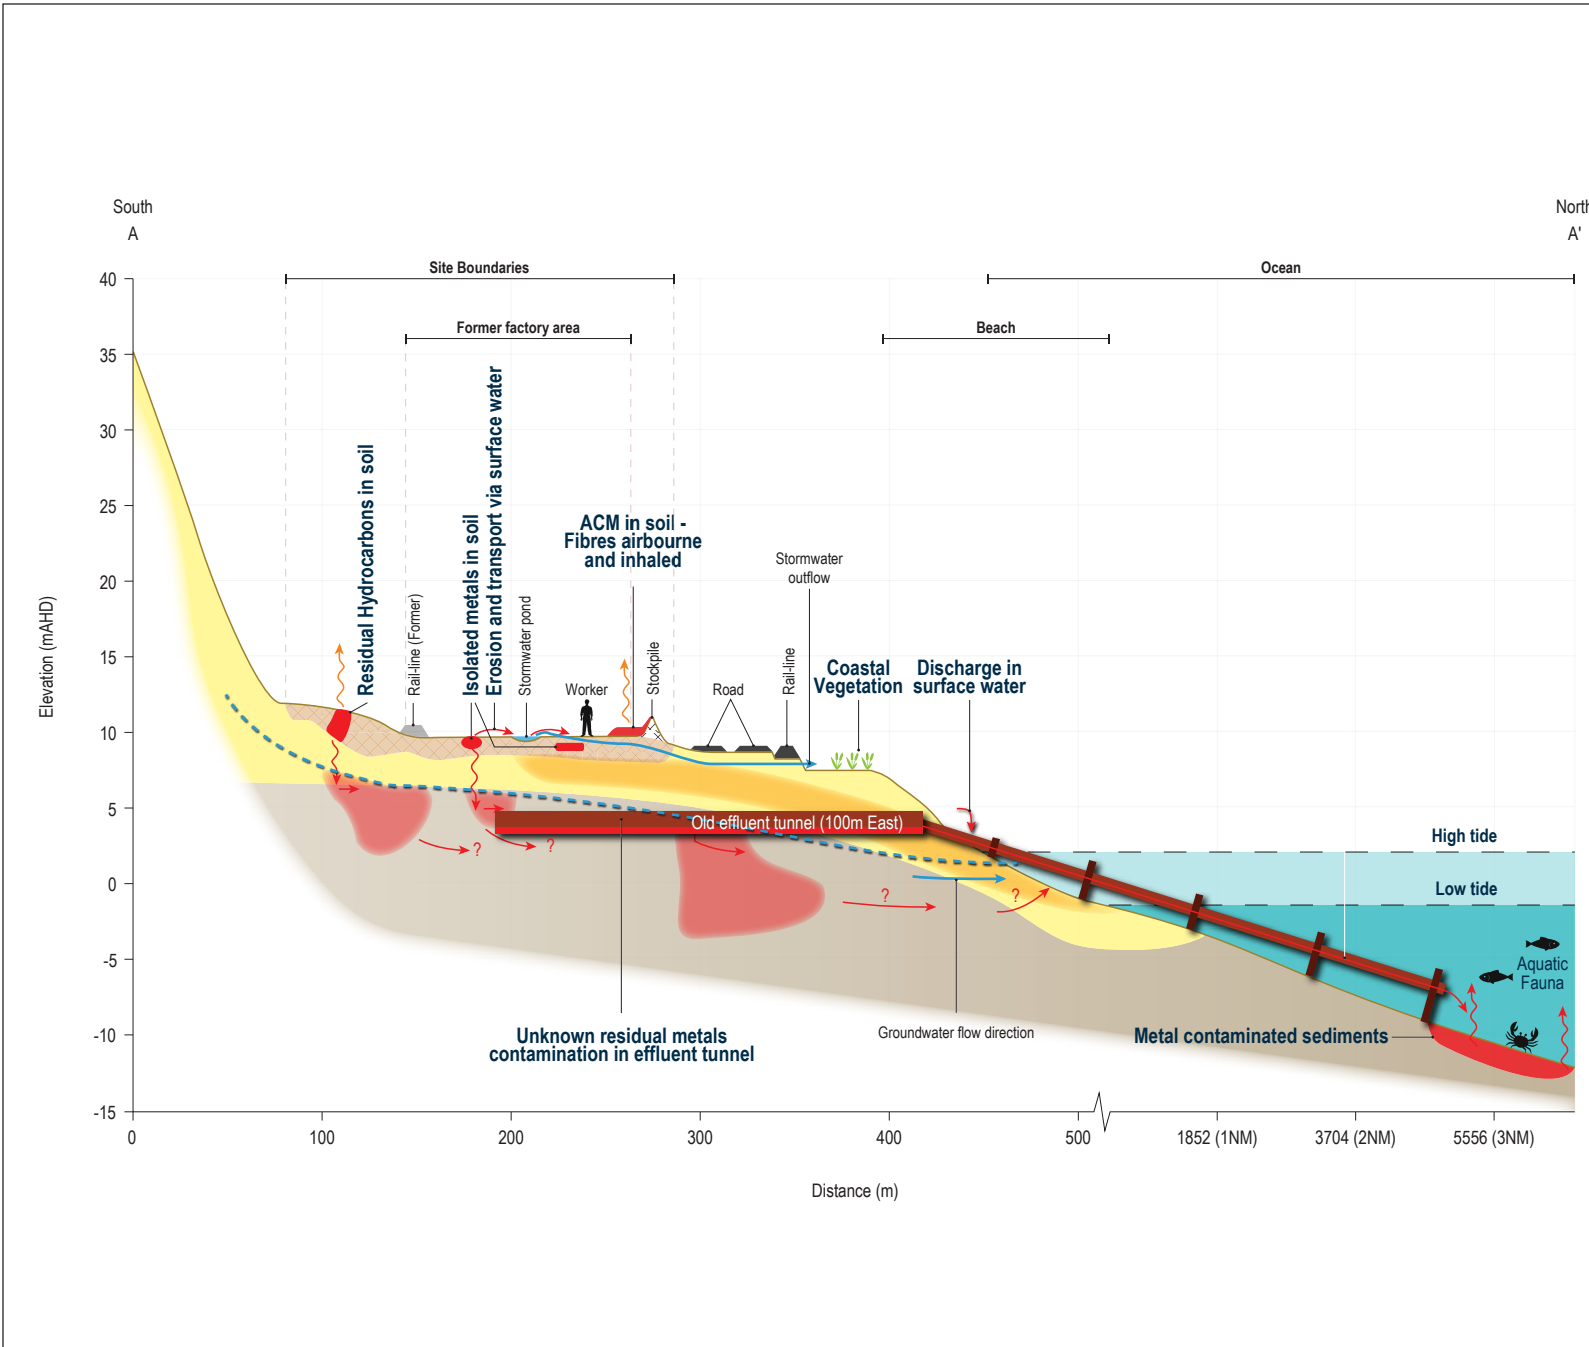
- Fill
- Sand
- Potential acid sulfate soils
- Quartz-wacke
- Effluent piping
- Leaching/groundwater transport plume
- Volatilisation
- Leaching
- Potential Migration
- Groundwater

- Potential ASS within soils at the converter station site and between the converter station and the low-tide line that if disturbed or dewatered may result in generation of acid that impacts on human health, built structures, terrestrial or aquatic biota, or cultural heritage artefacts.

- Contaminated sediments approximately 5km offshore that may impact on benthic biota if disturbed (addressed in the Marine Ecology and Resource Use Impact Assessment (EnviroGulf, 2024)).

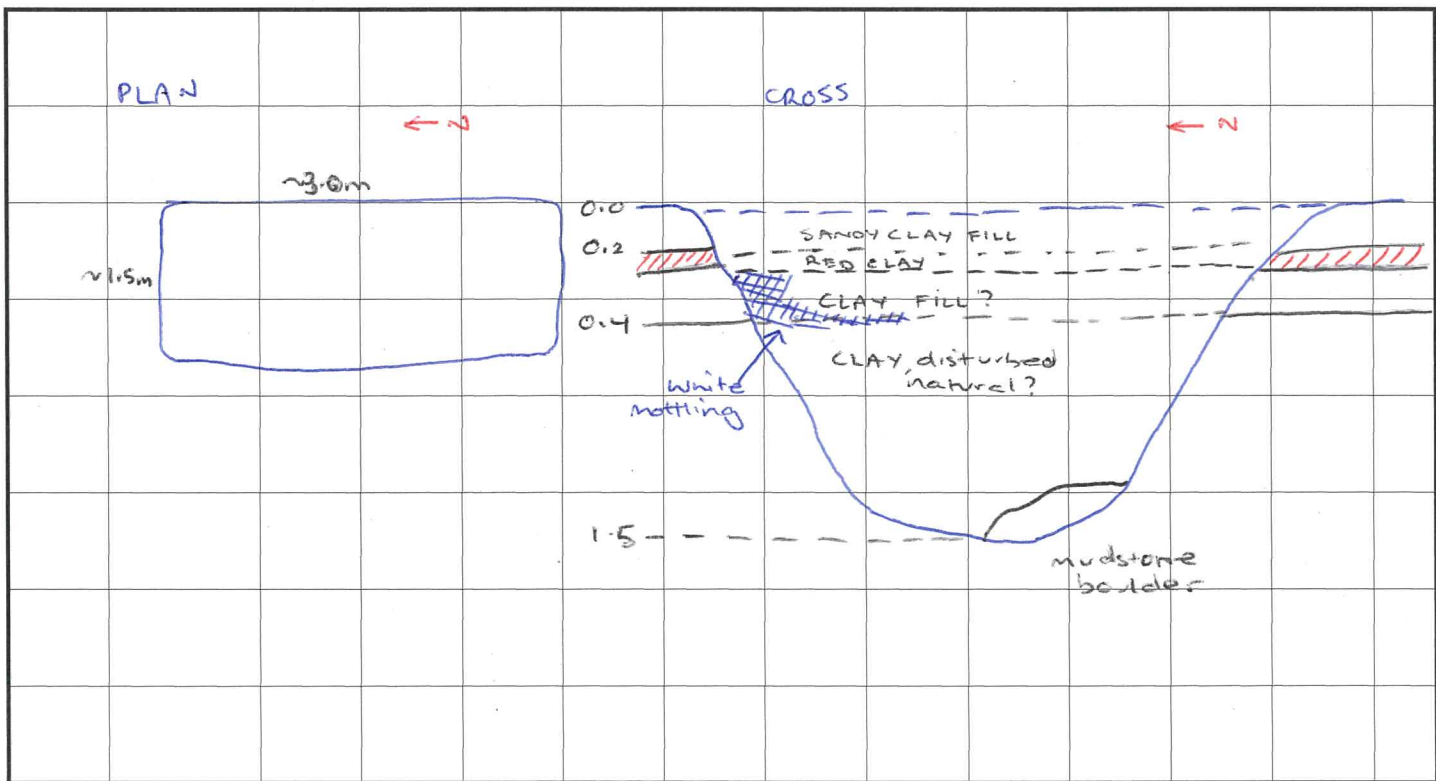
Sample ID	Soil Description (soil type, moisture, colour etc)	Depth (m)	Staining/ Odour (descriptive)	PID (ppm)
FILL HEY2_0002	Sandy CLAY, with gravels, red-brown	0.0-0.2	N/A	N/A
HEY2-0.6-0.7	CLAY, dark-brown with rootlets and charcoal fragments	0.6-0.7	"	"
—	misplaced sample 0.9-1.0		"	"
DIST NAT? HEY2-1.4-1.5	CLAY, dark brown with mudstone boulder disturbed natural? moist.	1.4-1.5	"	"

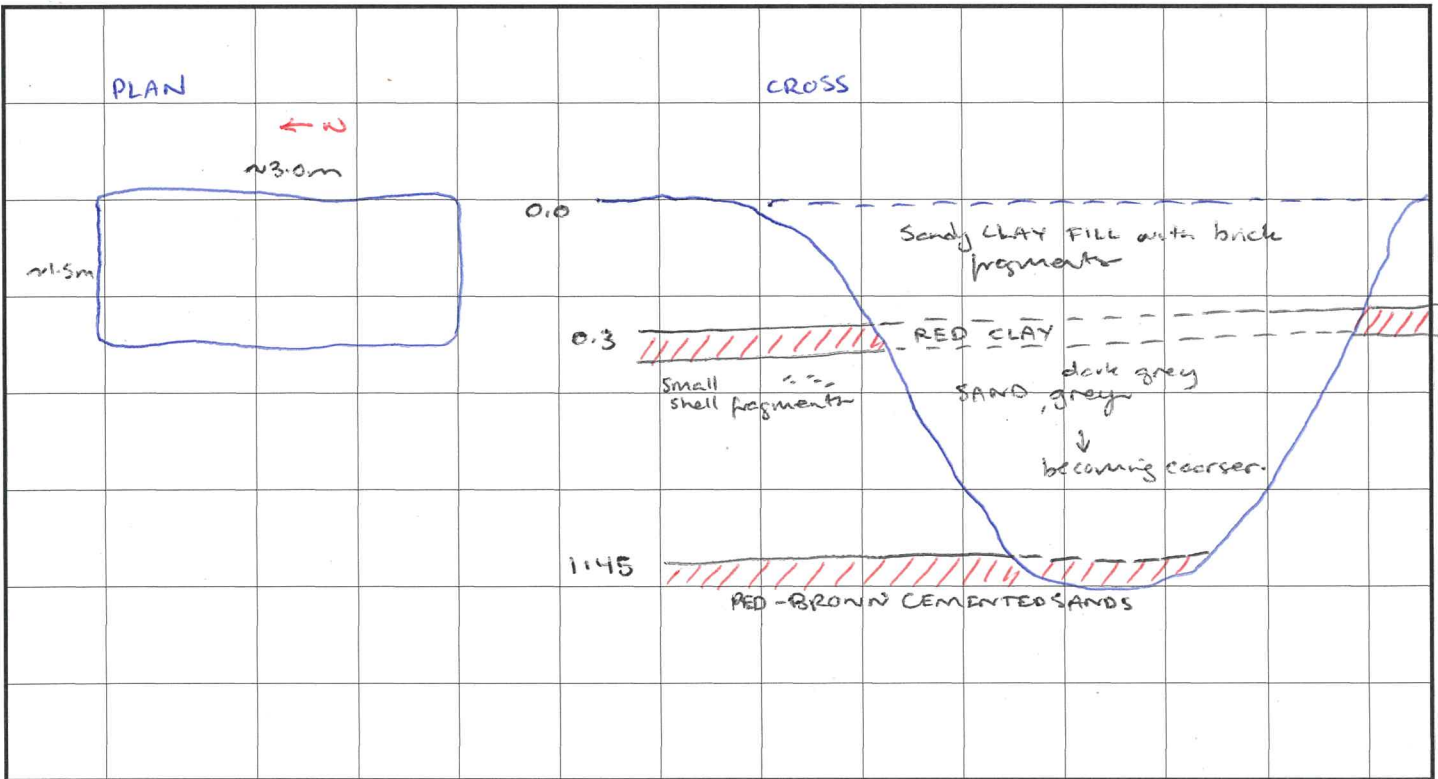
Sample ID	Soil Description (soil type, moisture, colour etc)	Depth (m)	Staining/ Odour (descriptive)	PID (ppm)
FILL HEY3-0.0-0.2	sandy CLAY with gravels, Fill, rubbish (brick) fragments, dark brown	0.0-0.2	N/A	N/A
NAT. HEY3-0.4-0.5	SAND, grey with small shell fragments m-cg	0.4-0.5	"	"
QC05 QC06 HEY3-0.9-1.0	SAND, grey, becoming coarser, quartz fragments, cg	0.9-1.0	"	"
HEY3-1.4-1.5	SAND, cg, dark grey with oxidised red-brown coloured cemented layer at 1.45m bgs	1.4-1.5	"	"

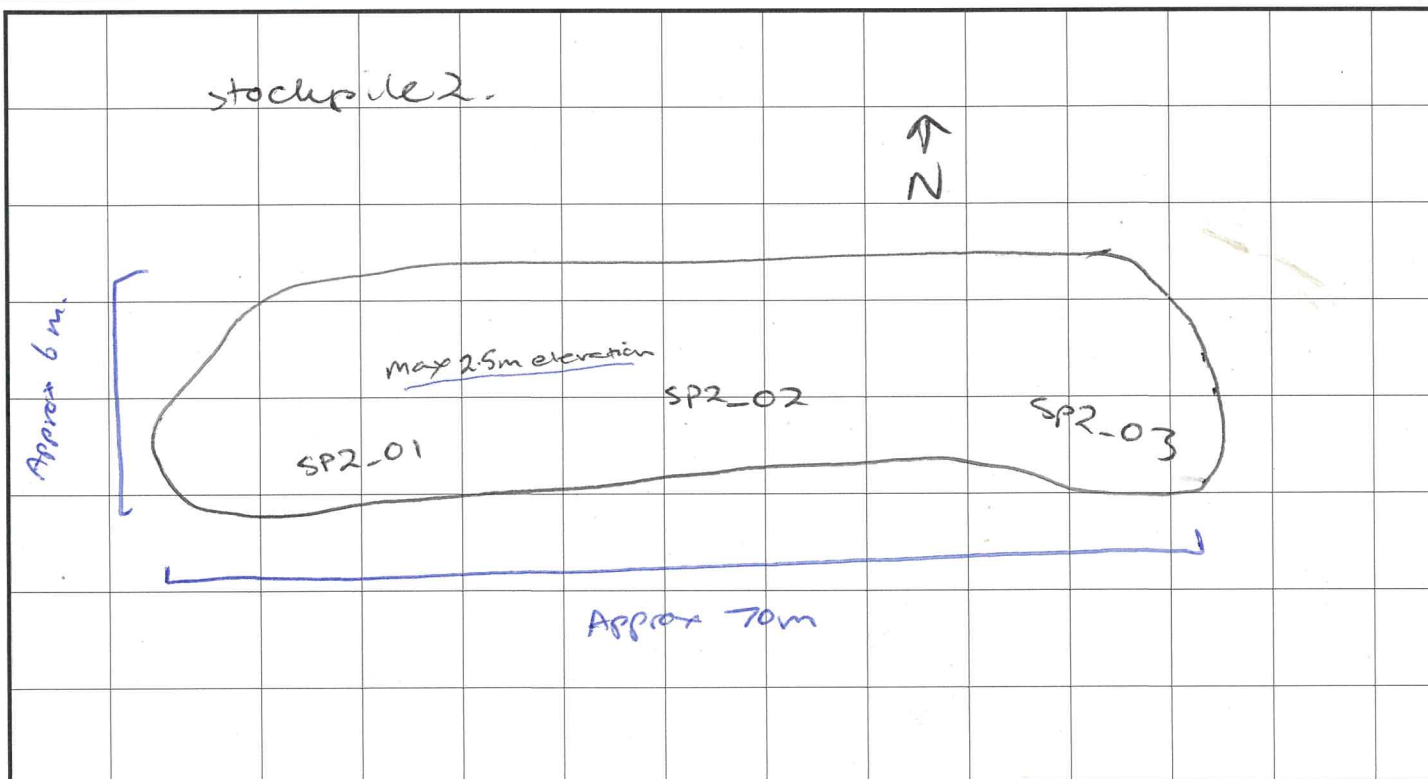
Sample ID	Soil Description (soil type, moisture, colour etc)	Depth (m)	Staining/ Odour (descriptive)	PID (ppm)
SP201	sandy CLAY with gravels + rubbish - plastic, clay pipe	0.2-0.3	organic odour	
SP202	sandy CLAY with gravels and concrete chunks	0.2-0.3	organic odour	
SP203	sandy CLAY with gravels and rubbish - glass fragments	0.2-0.3	organic odour

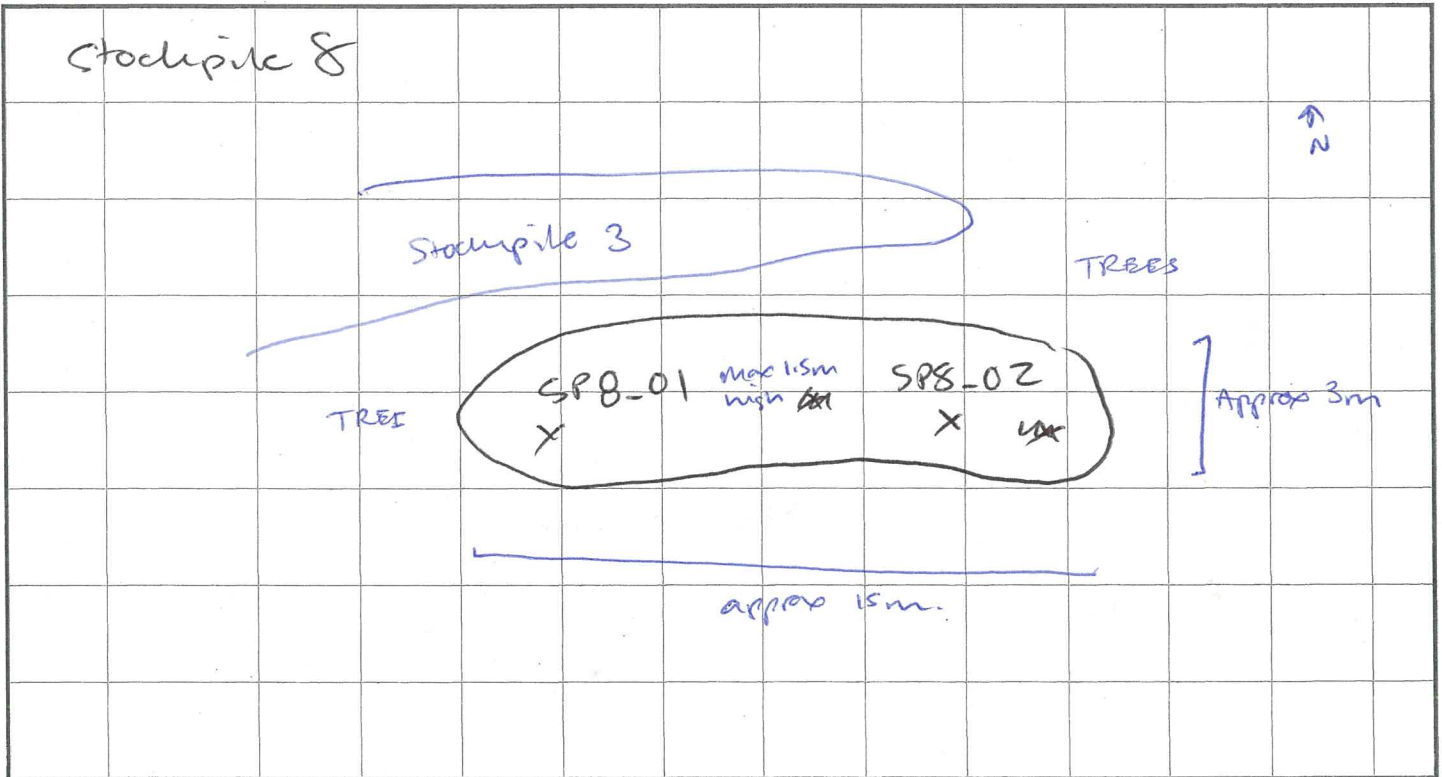
Sample ID	Soil Description (soil type, moisture, colour etc)	Depth (m)	Staining/ Odour (descriptive)	PID (ppm)
SP8-01	sandy CLAY with gravels - <del>None</del> no rubbish visible	0.2-0.3		
SP8-02	sandy CLAY with gravels	0.2-0.3

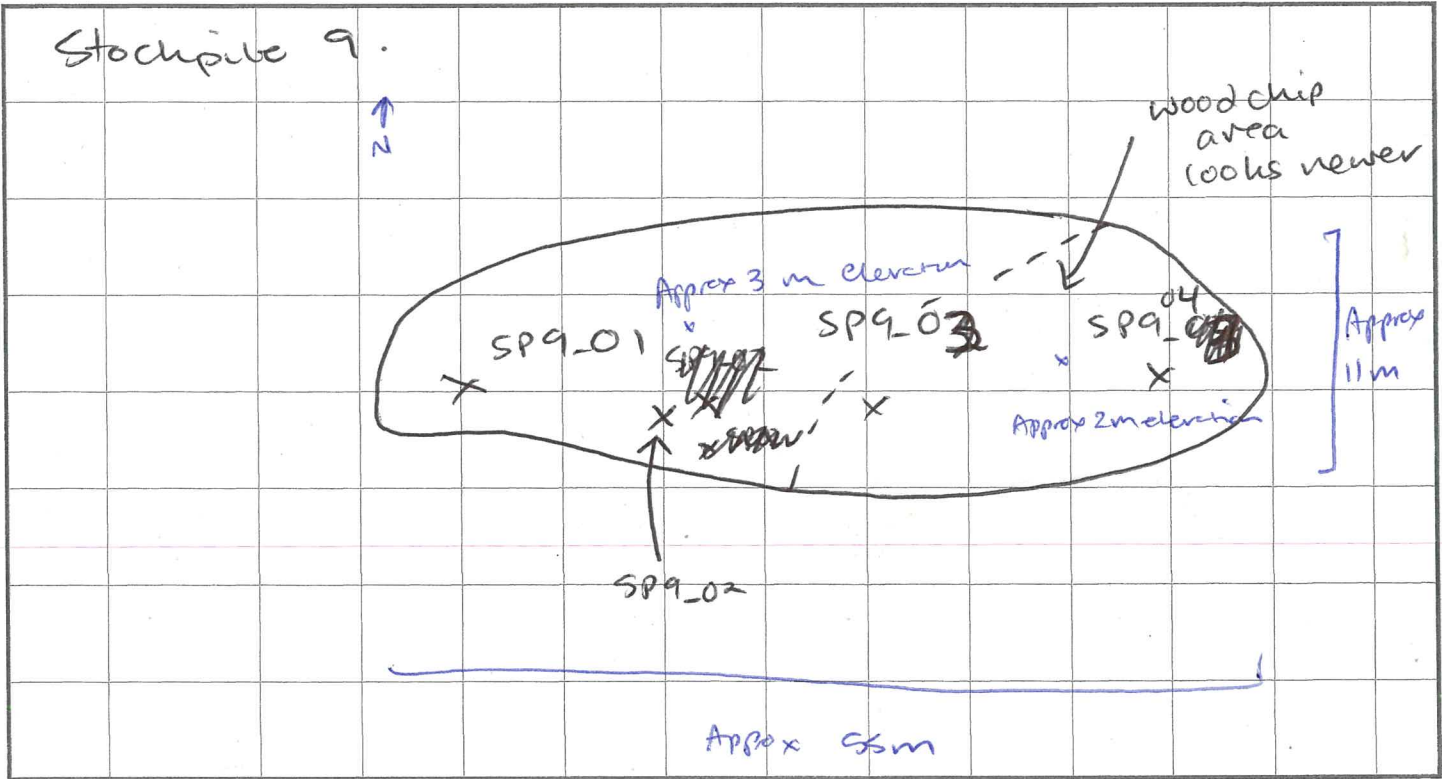
Sample ID	Soil Description (soil type, moisture, colour etc)	Depth (m)	Staining/ Odour (descriptive)	PID (ppm)
SP9-01	Sandy CLAY with gravel	0.2-0.3	Organic odour white staining	
SP9-02	Sandy CLAY with gravel and boulders	0.2-0.3		
SP9-03	Sandy CLAY with gravel. Dark brown and lots of bark chips.	0.2-0.3		
SP9-04	Sandy CLAY with gravel, dark brown and lots of bark chips	0.3-0.4
