Project: Project Marinus - Heybridge SI

Project: Heybridge Converter Station
Client:

Location: Heybridge Landside Landfall Site, Heybridge TAS

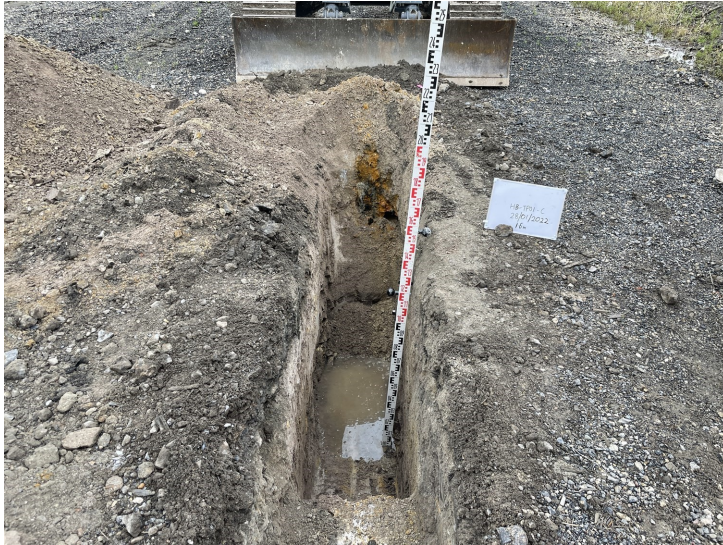
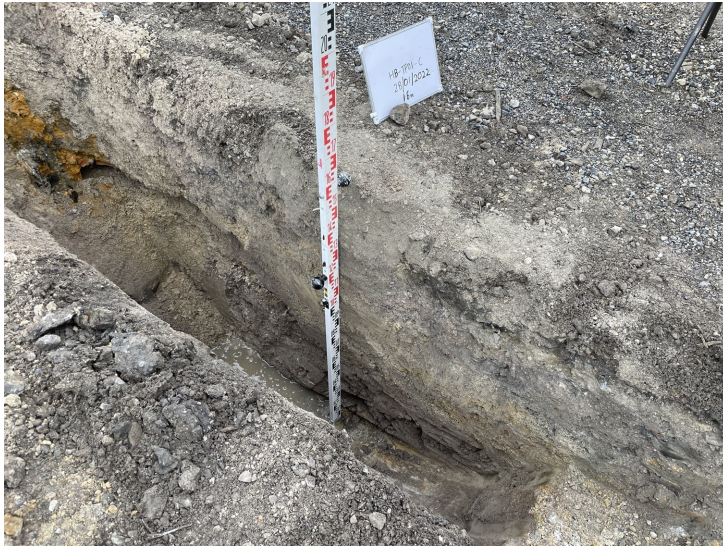
HB-TP01-C Depth Range: 0.00 - 1.60 m

EXCAVATION INFORMATION				MATERIAL SUBSTANCE								
Method	Penetration	Groundwater Levels	Samples & SPT Data	RL (m)	Depth (m)	Graphic Log	Material Description	Moisture	Consistency	Relative Density	DCP (blows/100mm)	Field Test Data & Other Observations
							SOIL TYPE: Plasticity or Particle Characteristics, Colour, Secondary and Minor Components					
					7		FILL: Sandy GRAVEL: fine to coarse grained, black, fine to coarse sand; with low plasticity silt		MD			FILL
			B		0.5		FILL: Gravelly SAND: fine to coarse grained, pale grey, fine to coarse grained gravel, low plasticity silt; with sub-angular to angular cobbles					0.10 : dosage = 63 nSv/hr
							Silty SAND: fine to coarse grained, yellow brown, low plasticity silt, with fine grained, angular to sub-angular gravel		M	D		0.30 : concrete fragments encountered
			B		1.0		0.90m: colour changing to pale grey brown, gravel content decreasing					0.50 : PP = 350 kPa, k = 0.261 W/mK, R = 383.142 Ccm/W, in-situ

Silty GRAVEL: fine to medium grained, angular to sub-angular, pale grey brown, low plasticity silt; with fine to coarse grained sand					AEOLIAN DEPOSITS Moisture Content : 11.6%, dosage = 110 nSv/hr
					6							0.70 : abandoned pipe encountered

1.5		Extremely Weathered QUARTZWACKE: recovered as Gravelly SAND: fine to coarse grained, grey brown, flakes of angular QUARTZWACKE gravels; with low plasticity silt		VD			1.00 : PP > 600kPa, k = 0.7448 W/mK, R = 134.261 Ccm/W, in-situ
							Exploratory hole terminated at 1.60 m Refusal					Residual Material Moisture Content = 12.5%, dosage = 115 nSv/hr, 1.4 CPS

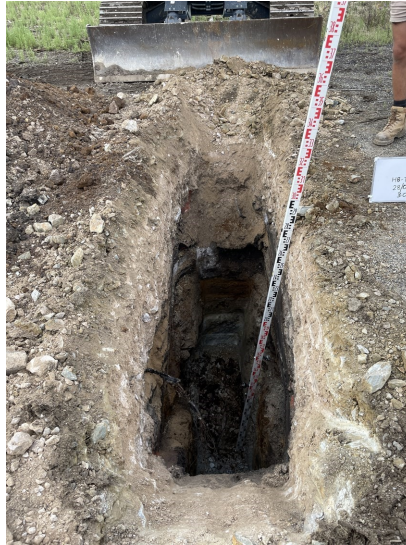
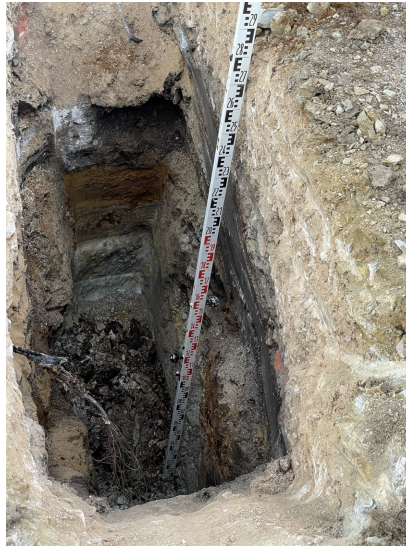
HB-TP02-C Depth Range: 0.00 - 3.00 m

EXCAVATION INFORMATION				MATERIAL SUBSTANCE									
Method	Penetration	Groundwater Levels	Samples & SPT Data	RL (m)	Depth (m)	Graphic Log	Material Description	Moisture	Consistency	Relative Density	DCP (blows/100mm)	Field Test Data & Other Observations	
							SOIL TYPE: Plasticity or Particle Characteristics, Colour, Secondary and Minor Components						
EU	Not Observed	Not Observed	B	0.0 - 0.5	0.0 - 0.5		FILL: Sandy GRAVEL: fine to medium grained, sub-angular to angular, dark grey, fine to coarse grained sand					FILL	
			B	0.5 - 1.0	0.5 - 1.0		Silty CLAY: low plasticity, orange brown; with fine to medium grained sand.					0.10 : dosage = 68 nSv/hr	
			B	1.0 - 1.5	1.0 - 1.5		Silty SAND: fine to medium grained, orange brown, low plasticity silt; with medium grained, sub-angular to sub-rounded gravel					0.50 : PP > 600kPa, k = 0.0981 W/mK, R = 1019.7 Ccm/W, in-situ RESIDUAL SOIL Moisture Content = 12%, dosage = 69 nSv/hr

B	1.5 - 2.0	1.5 - 2.0							0.70 : abandoned electrical cable encountered, PP > 600 kPa, k = 2.3335 W/mK, R = 42.85 Ccm/W, in-situ moisture content = 72%	
			B	2.0 - 2.5	2.0 - 2.5								1.00 : dosage = 77 nSv/hr
			D	2.5 - 3.0	2.5 - 3.0		Extremely Weathered QUARTZWACKE: recovered as Gravelly SILT: low plasticity, pale grey, mottled white, fine to medium grained gravel sized angular flakes of QUARTZWACKE						1.70 : PID = 0.5 PPM (hydrocarbon odour)

4.0							2.50 : PID = 4.1 PPM	
					3.0							3.00 : PID = 0.2 PPM, dosage = 85 nSv/hr

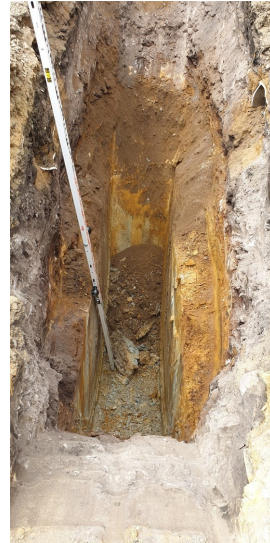
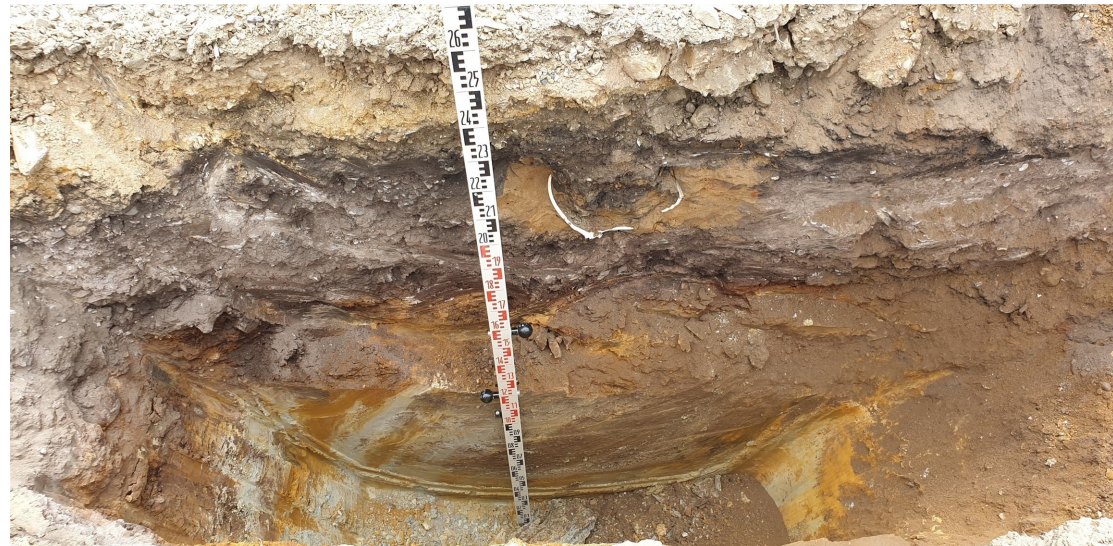
HB-TP03-C Depth Range: 0.00 - 3.00 m

EXCAVATION INFORMATION				MATERIAL SUBSTANCE							
Method	Penetration	Groundwater Levels	Samples & SPT Data	RL (m)	Depth (m)	Graphic Log	Material Description SOIL TYPE: Plasticity or Particle Characteristics, Colour, Secondary and Minor Components	Moisture	Consistency Relative Density	DCP (blows/ 100mm)	Field Test Data & Other Observations
LU 		D D D	D D	8			FILL: Sandy GRAVEL: fine to coarse grained, sub-angular to angular, fine to coarse grained sand; with angular to sub-angular cobbles	D		FILL 0.10 : PID = 0 PPM, dosage = 0.8 CPS 0.50 : PP > 600 kPa, k = 0.0735 W/mK, R = 1359.7 Ccm/W, in-situ moisture content = 6.6 %, PID = 0 PPM, dosage = 1.0 CPS

0.5			FILL: GRAVEL: angular to sub-angular, coarse grained, grey, with fine to coarse grained sand	MD-D			
				7			1.40m: light brown sand clay cobble present 20mm - 60mm	MD		1.00 : PP > 600 kPa, k = 1.7370 W/mK, R = 57.57 Ccm/W, in-situ moisture content = 7.5%, PID = 0 PPM, dosage = 1.2 CPS

2.5			Sandy SILT: low plasticity, grey brown, fine to coarse grained sand; with coarse grained, angular to sub-angular gravel	VSt		RESIDUAL SOIL	
				3.0			Gravelly SAND: coarse grained, grey brown, medium to coarse grained, rounded to sub-rounded gravel	D-VD			
5				3.0		Exploratory hole terminated at 3.00 m Target depth

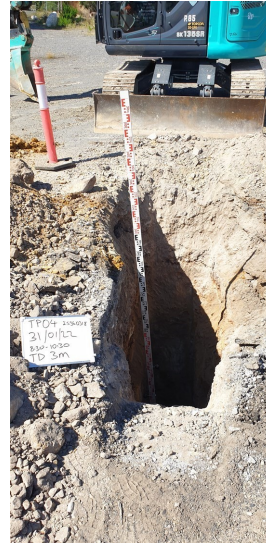
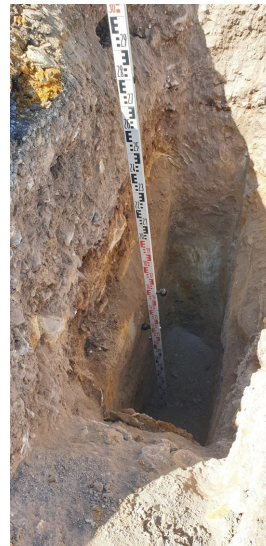
HB-TP04-C Depth Range: 0.00 - 3.00 m

EXCAVATION INFORMATION				MATERIAL SUBSTANCE								
Method	Penetration	Groundwater Levels	Samples & SPT Data	RL (m)	Depth (m)	Graphic Log	Material Description	Moisture	Consistency	Relative Density	DCP (blows/100mm)	Field Test Data & Other Observations
EU	Not Observed	Not Observed	D	10.0	0.5	[Cross-hatched pattern]	FILL: Sandy GRAVEL: medium to coarse grained, pale grey, fine to coarse grained sand	D	D	D	8-10	FILL 0.10 : PID = 0 PPM, dosage = 47 nSv/hr

0.90m: colour change to light brown aggregate/cobble size decrease	MD		0.50 : PP = 100 kPa, k=0.3500 W/mK, R=285.010 Ccm/W, in-situ moisture content = 0.6%

2.0		2.00 : dosage = 65 nSv/hr						
				2.5	[Cross-hatched pattern]	Sandy SILT: low plasticity, orange brown, fine to coarse grained; with coarse grained, sub-angular to angular gravel	M	St-VSt	16-20	2.30m: softer, moist/damp, weathered rock, siltstone, coarse sand with weathered material

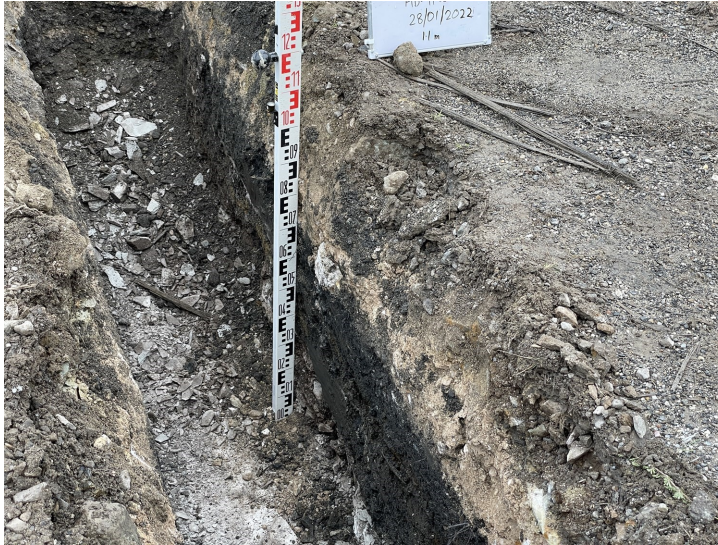
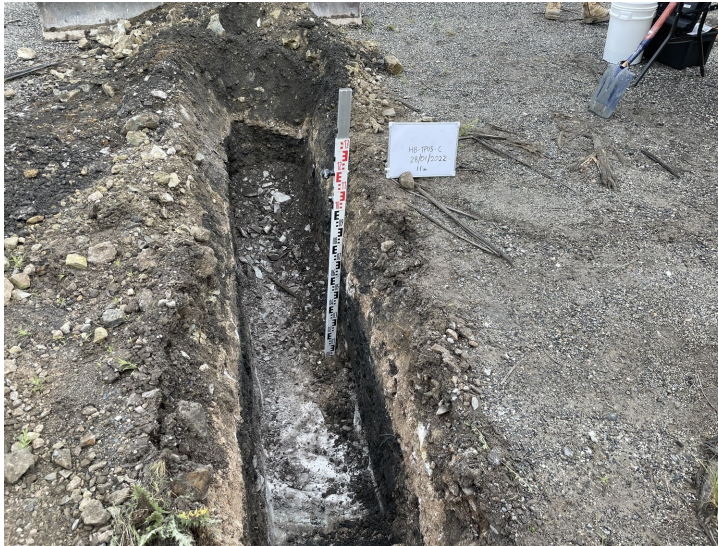
HB-TP05-C Depth Range: 0.00 - 1.10 m

EXCAVATION INFORMATION				MATERIAL SUBSTANCE									
Method	Penetration	Groundwater Levels	Samples & SPT Data	RL (m)	Depth (m)	Graphic Log	Material Description	Moisture	Consistency	Relative Density	DCP (blows/100mm)	Field Test Data & Other Observations	
							SOIL TYPE: Plasticity or Particle Characteristics, Colour, Secondary and Minor Components						
			B	8			FILL: Gravelly CLAY: low plasticity, dark grey, fine to medium grained gravel; with fine to coarse grained sand		D-VD			FILL 0.10 : PID = 0 PPM, dosage = 63 nSv/hr	
			B	0.5			FILL: Sandy GRAVEL: fine to coarse grained, sub-angular to angular, pale grey yellow, fine to coarse grained sand; with low plasticity silt, with cobbles		MD			0.50 : PP = 350 kPa, k = 0.1218 W/m ³ *K, R = 826.652 Ccm/W, in-situ Moisture content = 9.4%, PID = 0 PPM, dosage = 92 nSv/hr

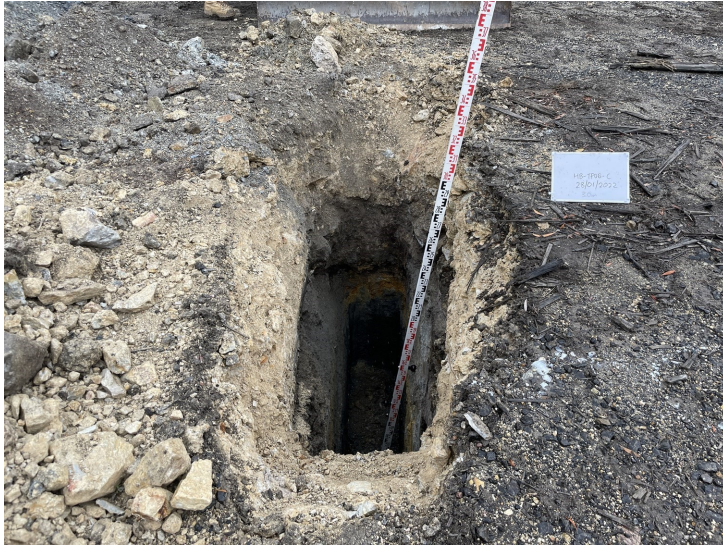
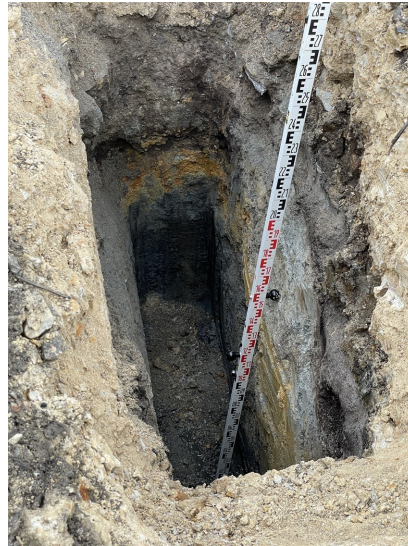
HB-TP06-C Depth Range: 0.00 - 3.00 m

EXCAVATION INFORMATION				MATERIAL SUBSTANCE								
Method	Penetration	Groundwater Levels	Samples & SPT Data	RL (m)	Depth (m)	Graphic Log	Material Description	Moisture	Consistency	Relative Density	DCP (blows/100mm)	Field Test Data & Other Observations
							SOIL TYPE: Plasticity or Particle Characteristics, Colour, Secondary and Minor Components					
					11		FILL: Silty Sandy GRAVEL: fine to medium grained, dark grey, low plasticity, fine to coarse sand	M	MD			FILL
			B		0.5		FILL: Sandy Gravelly CLAY: low plasticity, yellow brown, fine to coarse grained sand, fine to coarse grained, sub-angular to angular gravel; with sub-angular to angular cobbles, with boulders up to 250mm (sub-angular to angular)	M <Wp	H			0.10 : PID =0 PPM, dosage = 70 nSv/hr

1.0		FILL: Silty SAND: fine to medium grained, dark grey, low plasticity silt	M	MD			0.50 : PP >600 kPa, k = 0.0589 W/mK, R = 1697.0 Ccm/W, in-situ moisture content = 2.3%, PID =0 PPM, dosage = 68 nSv/hr
			D		10		1.20m: with fine to coarse, sub-angular to angular gravel; with boulders up to 250mm					1.00 : PP = 200 kPa, k = 0.6287 W/mK, R = 159.061 Ccm/W, in-situ moisture content = 10.5%, PID =0 PPM, dosage = 80 nSv/hr

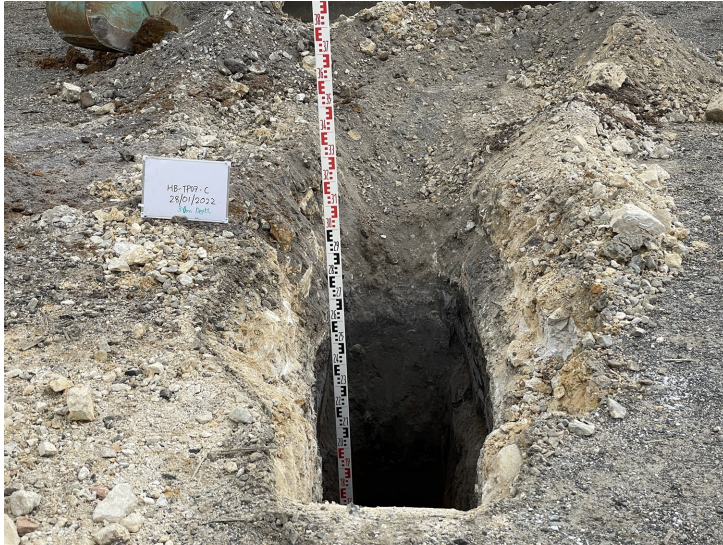
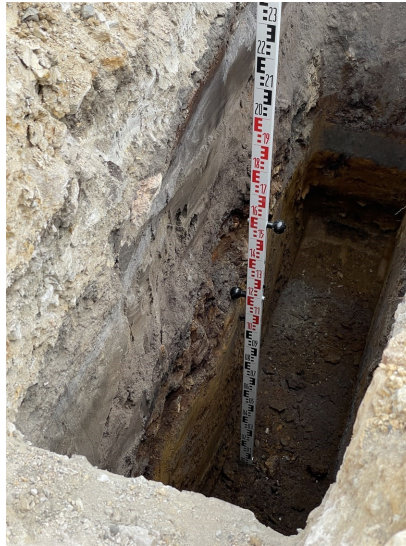
HB-TP07-C Depth Range: 0.00 - 3.00 m

EXCAVATION INFORMATION				MATERIAL SUBSTANCE								
Method	Penetration	Groundwater Levels	Samples & SPT Data	RL (m)	Depth (m)	Graphic Log	Material Description	Moisture	Consistency	Relative Density	DCP (blows/100mm)	Field Test Data & Other Observations
Method: EU Penetration: Not Observed Groundwater: Not Observed	B B B D	RL: 13.0 12.0 11.0 10.0	Depth: 0.0 0.5 1.0 1.5 2.0 2.5 3.0 3.5 10.0	0.0	0.0	FILL: Silty Sandy GRAVEL: fine to medium grained, dark grey, low plasticity, fine to coarse grained sand FILL: Clayey GRAVEL: fine to coarse, grained sub-angular, yellow brown, low plasticity clay; with fine to medium grained sand <i>0.35m: colour becoming yellow brown mottled red</i>	M	<Wp	H	5	FILL 0.10 : PID =0 PPM, dosage = 45 nSv/hr 0.50 : PP >600kPa, k = 0.2740 W/mK, R = 364.921 Ccm/W, in-situ Moisture content = 2.0%, PID =0 PPM, dosage = 52 nSv/hr

1.0	1.0	FILL: Gravelly Sandy CLAY: low to medium plasticity, grey brown, fine to coarse grained sand, fine to medium grained gravel Silty SAND: fine grained, dark grey, low plasticity silt	L		AEOLIAN DEPOSITS 1.00 : PP = 300 kPa, k = 1.0899 W/mK, R = 91.75 Ccm/W, in-situ moisture content = 3.7%, PID =0 PPM, dosage = 80 nSv/hr
